# Report on the Battle of Dogger Bank by the Austro-Hungarian Naval Attaché in Berlin, Fregattenkapitän Colloredo-Mannsfeld

Essay by Mihály Krámlí

Visit of His Majesty the German Emperor in Wilhelmshaven

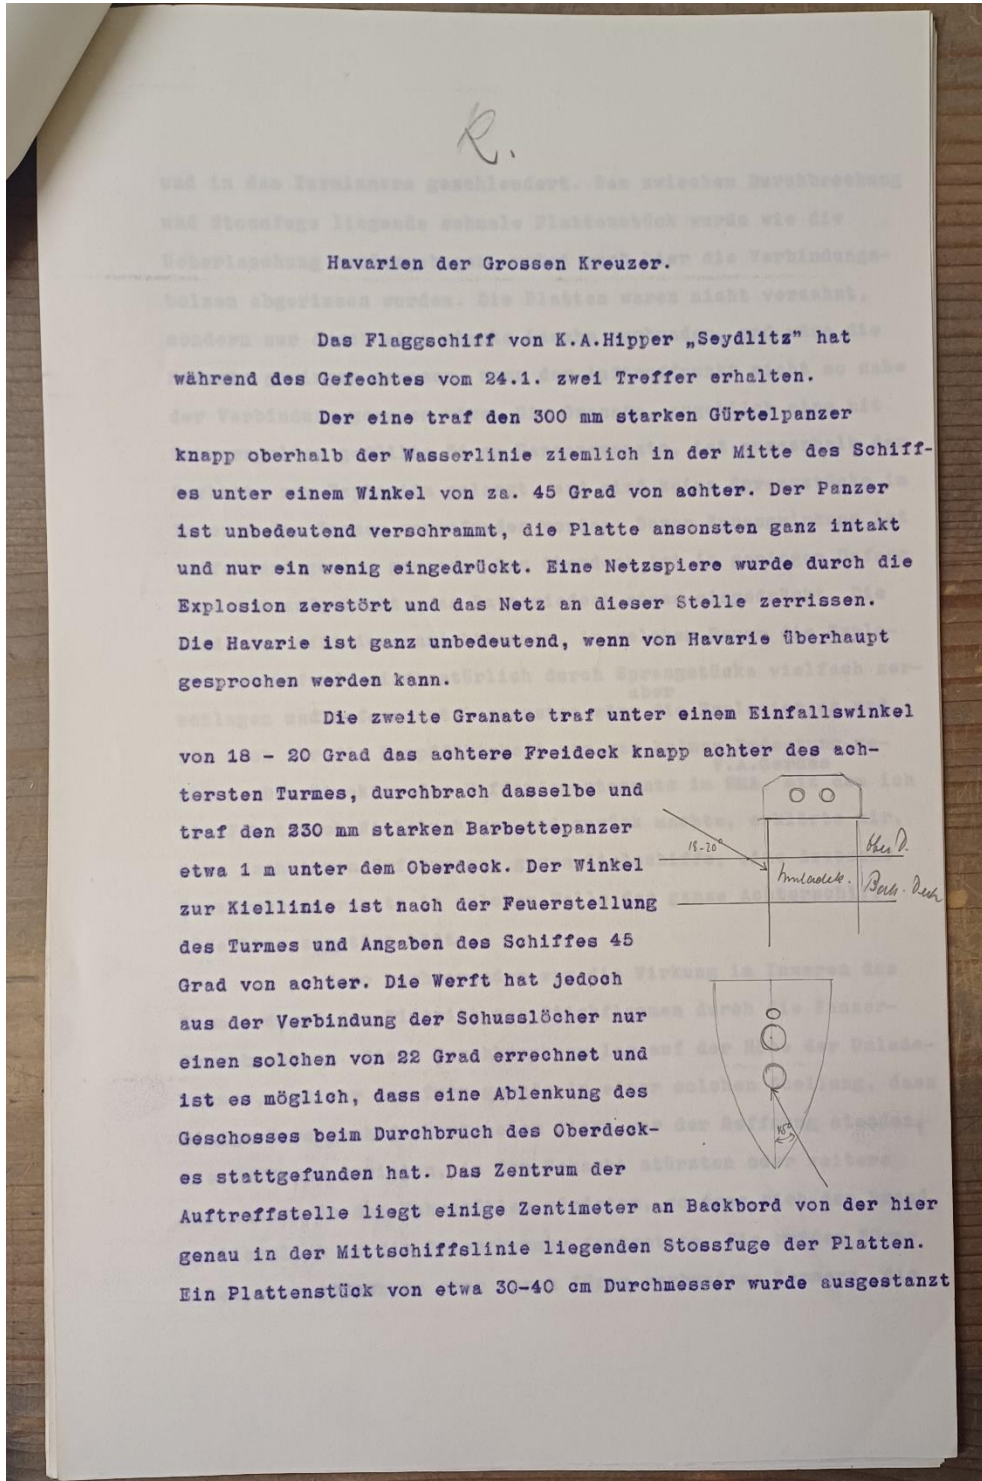
Portion of the report describing the “fatal hit” on Seydlitz

The second shell hit the aft open deck just aft of the aftermost turret<sup>12</sup> at an angle of incidence of 18-20 degrees, broke through it and hit the 230 mm barbette armor about 1 m below the upper deck. The angle to the keel line is 45 degrees from aft according to the turret's firing position and the ship's specifications. However, the shipyard only calculated an angle of 22 degrees from the connection of the shot holes and it is possible that the projectile was deflected when the upper deck was penetrated. The center of the point of impact lies a few centimeters to port from the butt joint of the plates, which lies exactly on the midship line. A piece of plate about 30-40 cm in diameter was punched out and hurled into the interior of the turret. The narrow piece of plate lying between the hole and the butt joint was bent back like the overlapping lashing, whereby the connecting bolts were also torn off here. The plates were not interlocked, but only connected by a strong lug, and the damage would have been less if the point of impact had not been so close to the joint. The shell, allegedly a 34 cm shell<sup>13</sup> filled with black powder, exploded outside the barbette and no splinters were found inside the turret. Its explosive effect was remarkably low. The upper deck is slightly dented by about 1 m [probably in diameter], the battery deck is somewhat dented. The walls of the officers' pantry, in which the explosion took place, were of course shattered and deformed in many places by splinters, but otherwise the explosion in and of itself would have been of no significance for the combat capability. The director of the Weapons Department [Waffendepartment] in the RMA, V.A. [Vizeadmiral] Gerdes, with whom I made the trip to Wilhelmshaven and back, explained to me that according to their experience against target ships, a German armor-piercing shell in such a case would have infallibly destroyed the entire aft portion of the ship.

The effect inside the turret was all the more devastating due to the entry of jet flames through the hole in the armor. This hole was at the level of the working chamber [Umladestation], and the turret was in such a position that some ready cartridges were close to the opening. These caught fire, fell into the shaft or ignited further cartridges in the hoists, so that the fire finally spread down into the magazine. The two [after] turrets have separate magazines connected by hatches, which must have been open, as the fire also spread to the other magazine.

Around 10 tons<sup>14</sup> of propellant burned in both magazines until the flooding of the magazines<sup>15</sup> put an end to any further danger. The insides of both turrets were, of course, completely burnt out, and the flames reached up to about mast height from all openings, and the paint on the outside of the turrets was burnt wherever a flame found its way out. Gases penetrated into the surrounding compartments, causing symptoms of poisoning to the people inside. However, the men in the aft conning tower, which is close to the forward turret [aft superfiring], remained unharmed. The entire crew of both turrets and the magazines, 160 men, were burnt to death and 30 were seriously injured.<sup>16</sup>
