Kirishima Damage Analysis

By Robert Lundgren
Edited by Tony DiGiulian

1. Introduction

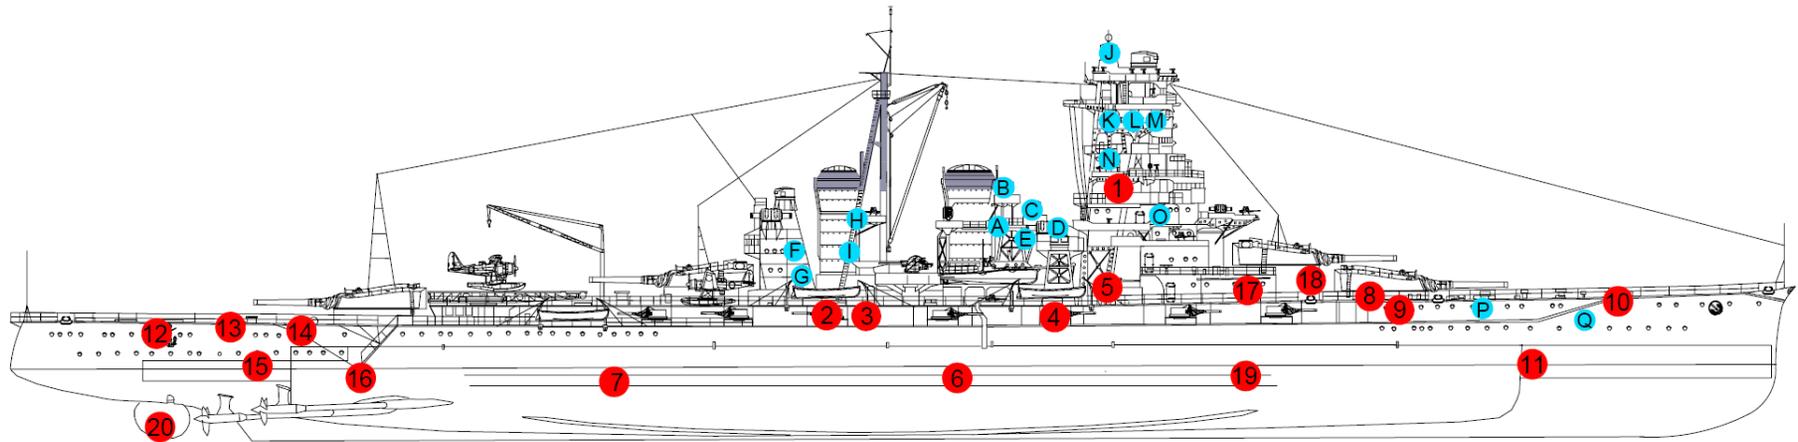
Exterior Starboard profile

Ikeda's sketch of her damage is probably the most important new piece of evidence as to *Kirishima*'s damage. The 20 major caliber and 17 secondary caliber hits is far more consistent with what may be expected by the number of major caliber shells and secondary shells fired at their respected ranges. In addition all the hits that struck the ship below the waterline would have been observed by *Washington* as a miss due to the shell throwing up a splash. Some hits so close together may have been observed as single hits so the 8-9 hits viewed optically becomes a realistic estimate but falls short of actual damage.

Please increase view to 150-200% to view drawings in more detail. One note is that this drawing still shows all her boats and aircraft on board but before the battle all boats were landed and she had launched her aircraft in an attempt to spot the US formation. None were aboard during the battle and her aft aircraft crane would have been folded down in order to allow full training arcs for turret three.

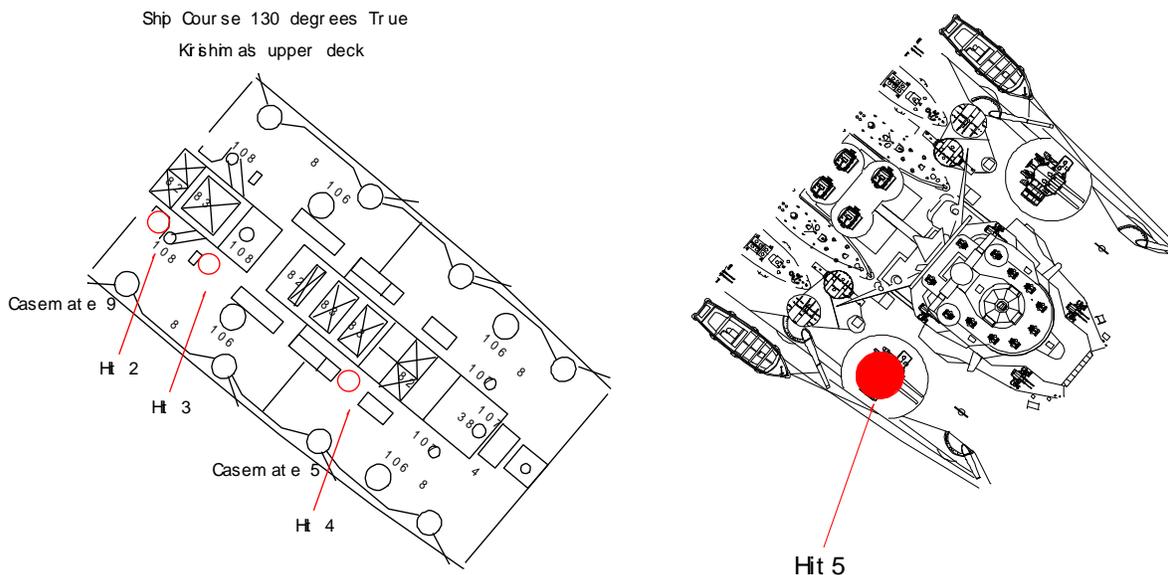
Hits 2, 3, 4, 5, 6, and 7 – play the most important role in why *Kirishima* was lost. Ikeda observed two ten meter wide holes in the deck right above his secondary guns as he moved aft in all likelihood these were hits 2 and 3. Holes thirty feet in diameter hint on how violent these explosions were and both strike very close to casemate mount 9. Hit 3 struck close to casemate mount 5. Hit 4 would have struck at the base of the pagoda superstructure in the approximate position of the forward 5"/40 gun mount. The drawings below are turned to reflect *Kirishima* on a course of 130 degrees and the shell trajectory matches *Washington*'s course, position and firing angle during the first two minutes and 39 seconds. Hank Seely noted that on *Washington*'s third salvo *Kirishima* was hit amidships, causing large, bright explosions.

The damage done by hits 2, 3, and 4 is very significant in that after penetration of the 149 mm casemate armor the shells would detonate very close to her forced draft supply ventilation for her machinery compartments (number 82). In addition, hits 2 and 3 threaten the aft secondary magazines through ammunition scuttles (number 41) on the lower deck and fires can sweep across to the port side as well,

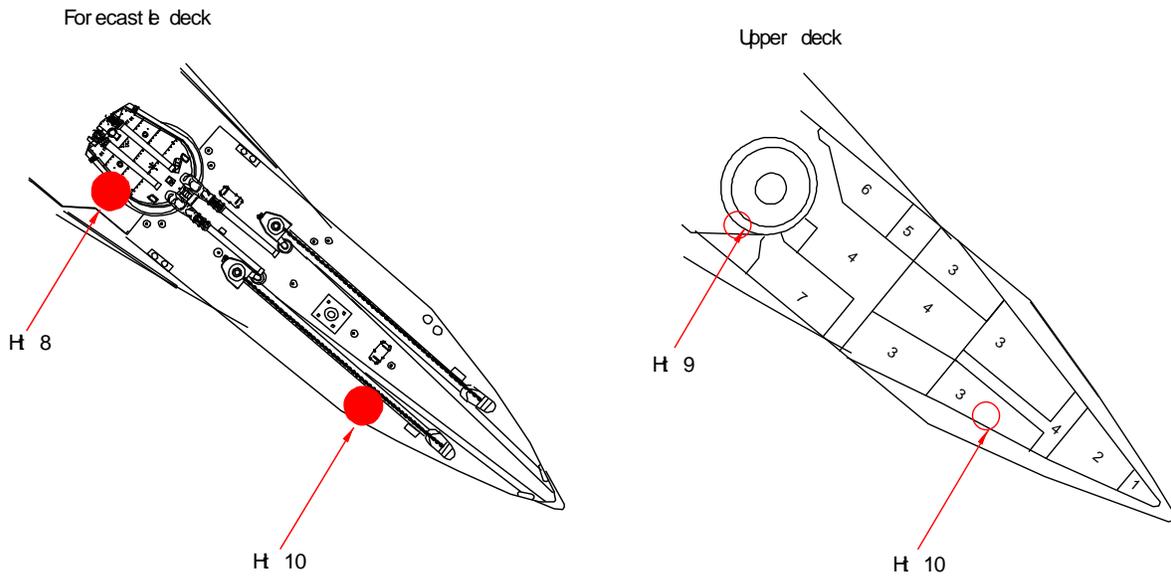
Based on Hayashi's drawing, hit 8 may have struck the barbette above the forecastle deck or hit the deck first and then struck the barbette on the after section of the barbette. Hit 9 penetrated between the forecastle deck and upper deck and would have passed through the 149 mm VC casemate armor that angles to the center of the barbette and then through a 75 mm VC plate. The armor protection in this area is too thin to stop the projectiles. Hit 10 may also have struck the forecastle deck and then penetrated the 38 mm NS deck plating to enter crew quarters and passage ways.

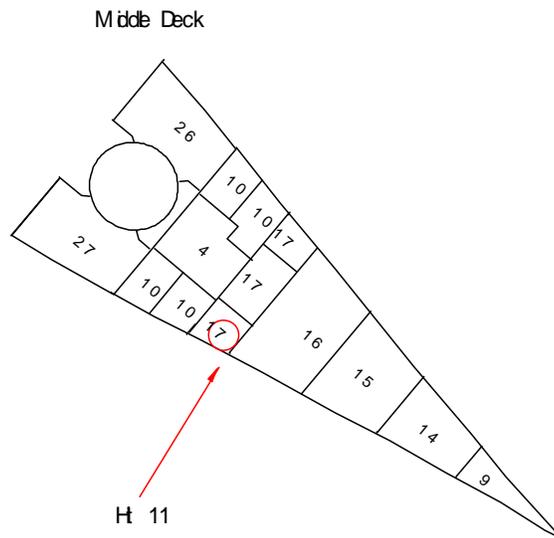
Hit 11 struck below the waterline and would have penetrated the forward 75 mm VC plate and hit the forward chain locker (number 17). This damage may play a role in determining why the forward chain is draped over the stern of the wreck.

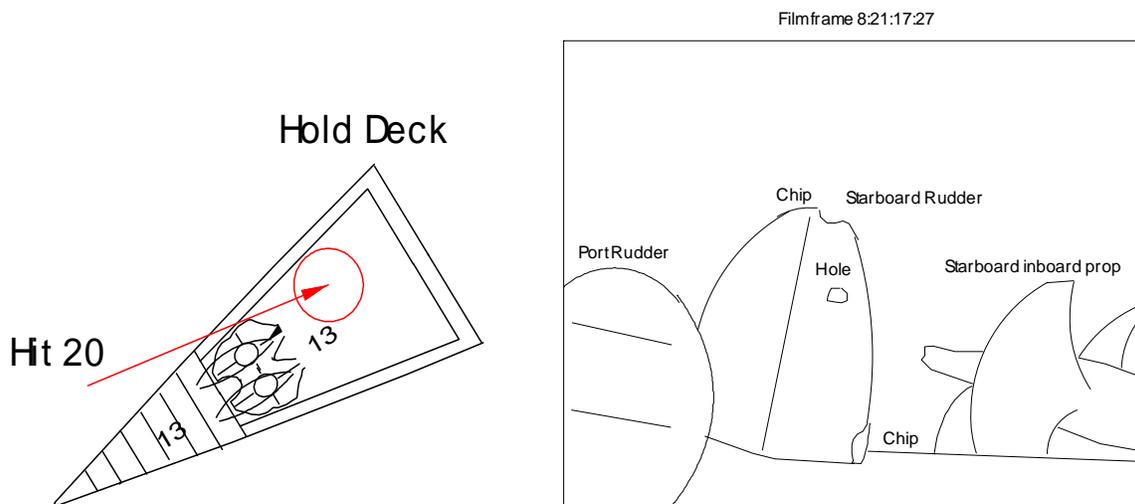
Hit - 20 was placed on her rudder itself. At 0107 *Kirishima* was documented as turning to port in a 500 degree turn before she stopped. Why would a ship turn to port if her rudders are jammed at 10 degrees starboard? Her wreck shows her starboard rudder is at 10 degrees starboard just as her officers documented. This 10 degrees to starboard is bringing the ship on a steady course after her port turn to the north when the control room floods and loses power.

The port rudder however is turned almost 80 degrees inboard. Normally her rudders could only turn 30 degrees off center so this 80 degree turn represents a massive jam and with her starboard rudder only off center by 10 degrees the water trapped by the port rudder would pull the ship to port. So what may have happened to cause this type of jam? One theory would be at 0107 as *Washington* fires her last salvo as *Kirishima* is presenting her port side to *Washington*. This salvo of shells fall around her stern and one shell manages to come under her keel behind the rudders and forward of the inboard propellers and detonates. The shock of the explosion hits the rear of the port rudder and slams it to 80 degrees starboard. The shock under her keel breaks the seals and the rudder machinery room floods and the watertight scuttles to these compartments jam. In addition, there is evidence of shrapnel damage to the starboard rudder with one fragment penetrating, chips out of the top and at the base at the rear of the starboard rudder. Surprisingly, there is no good film of the port rudder, it simply looms in the darkness. You can tell that it is jammed, but there is not enough light to see if it suffered any shrapnel damage.

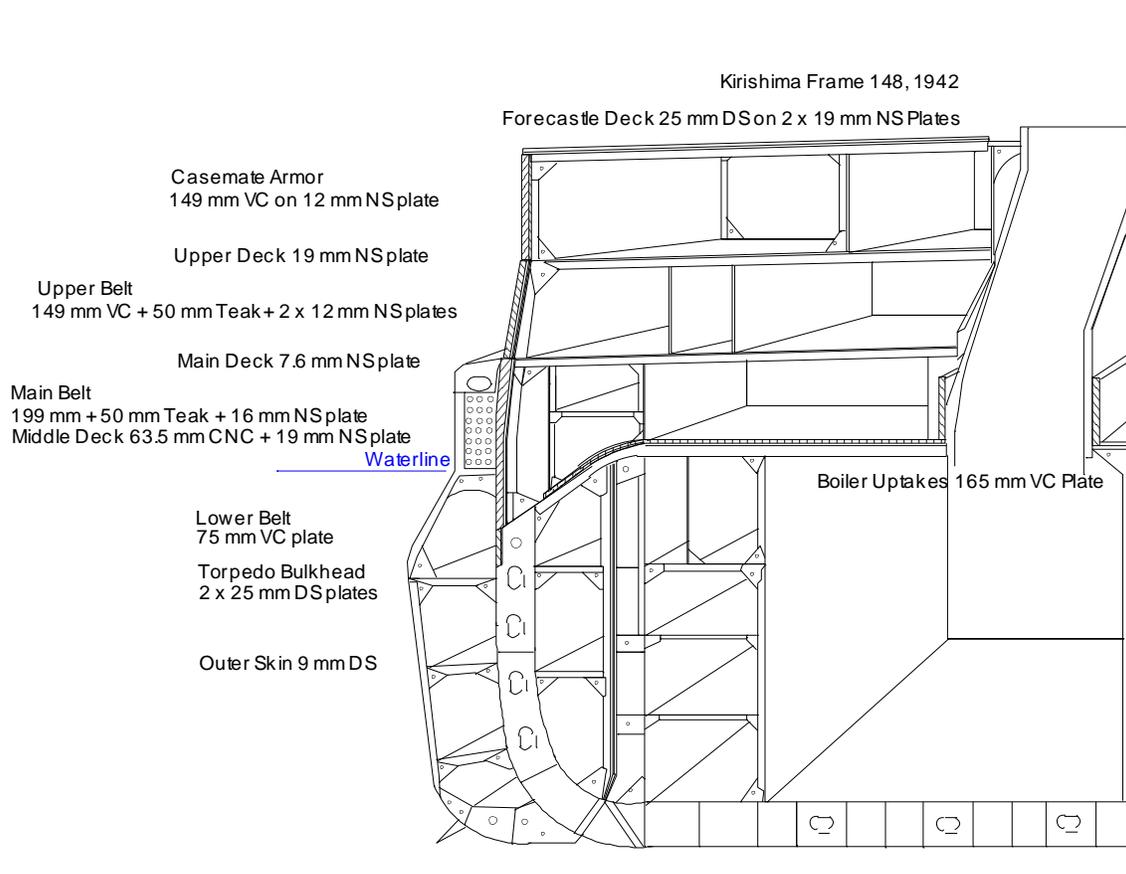
This first cross section is at frame 148 of *Kirishima* as she was after she was modernized and shows her basic subdivision and armor protection. Her side armor largely remains the same and the Japanese focused on increasing torpedo protection and added some deck protection to the middle deck. Her main belt was not designed to protect her machinery but to protect her buoyancy at the waterline. It is far too narrow to protect her machinery and is there to keep the middle deck dry.

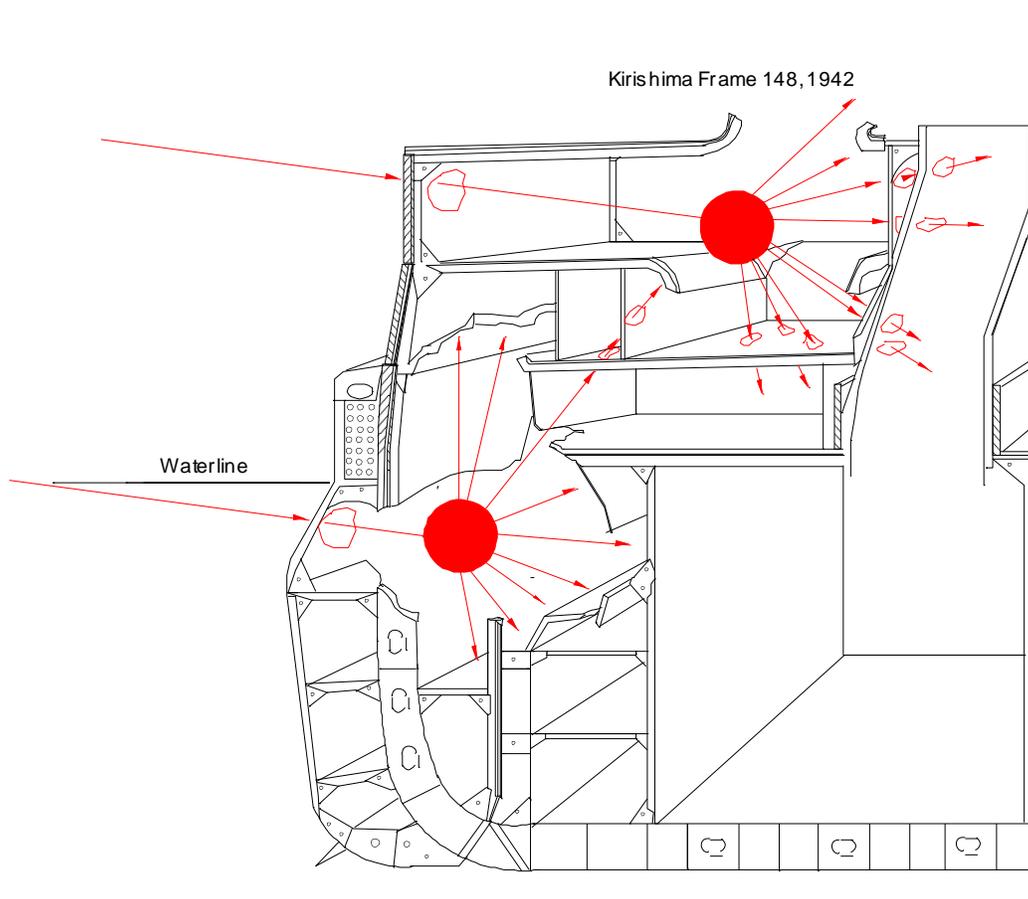
The next cross section shows how devastating the amidships hits would be in breaking her watertight integrity to the decks normally above the waterline. *Kirishima's* original protection scheme was never based on projectiles with deep penetration capability. In 1914 all that was expected from an AP shell was to punch a hole in the exterior plate. These projectiles exploded on impact using a very sensitive explosive filler of picric acid and a non-delay fuze. They posed little risk to the ship below the waterline as any shell would destroy itself on impact with the water. Thus in 1914 all major watertight compartments only went up to the middle deck which is located at the waterline. The decks normally above the waterline have huge compartments which allow the crew to move through the ship. By 1942 advances in shell technology allow projectiles to have deep penetration capability before they detonate. Her exterior armor too thin to stop penetration only ensures proper fuze action. Hit 6 striking just short of her hull passes through the lower edge of her main belt and breaking the tip of the armored slope and detonates under the slope probably when the shell struck the torpedo bulkheads. This devastates the middle deck above opening it to the sea. *Kirishima* is largely liquid loaded below the waterline amidships and the fuel liquid stops the shell fragments from reaching the boiler room. Though the shell hits 2, 3, 4, and 5 struck farther forward and aft of this frame the cross section can be used to show how hits to the casemate armor devastate her watertight integrity. Her upper deck of 19 mm NS steel and the main deck of 7.6 mm NS steel are incredibly thin for World War II standards. It would normally take 63 mm of STS armor to stop BB caliber fragments and by World War II NS steel is not considered armor grade. The 63.5 mm of CNC armor added to the middle deck during modernization provided no protection because

the shell detonated beneath it and the armor did not extend to the tip of the slope where the shell penetrated. When you also add in secondary explosions from ready ammunition lockers and severe fires her upper decks have lost watertight integrity.

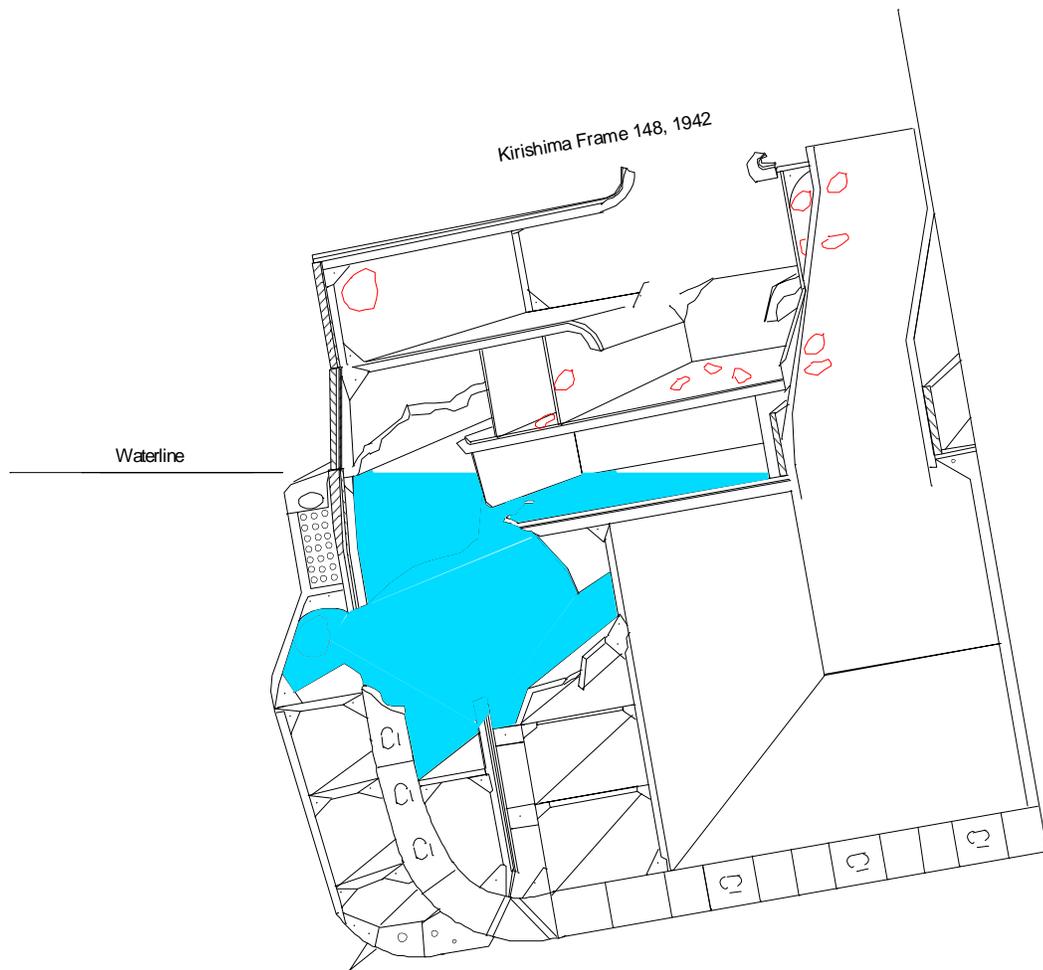
Then assume a 10 degree list to starboard and settling a few feet and the cross section shows how the middle deck begins to flood and the main deck is threatened by flooding if she settles further in the water.

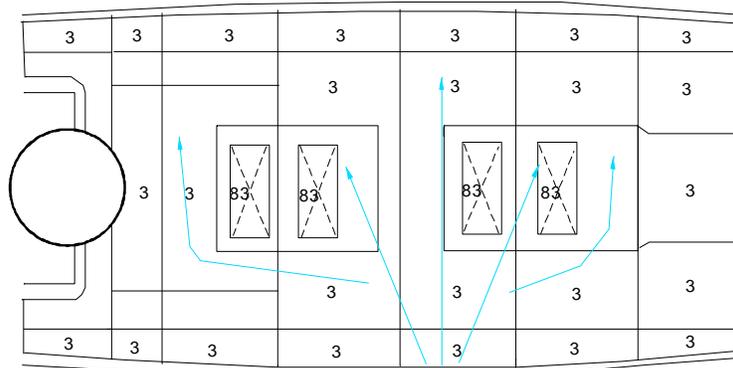
Progressive Flooding of Middle deck

Now look at the plan views of the middle and main decks to show how such progressive flooding produces a massive free surface effect that can travel from starboard to port.

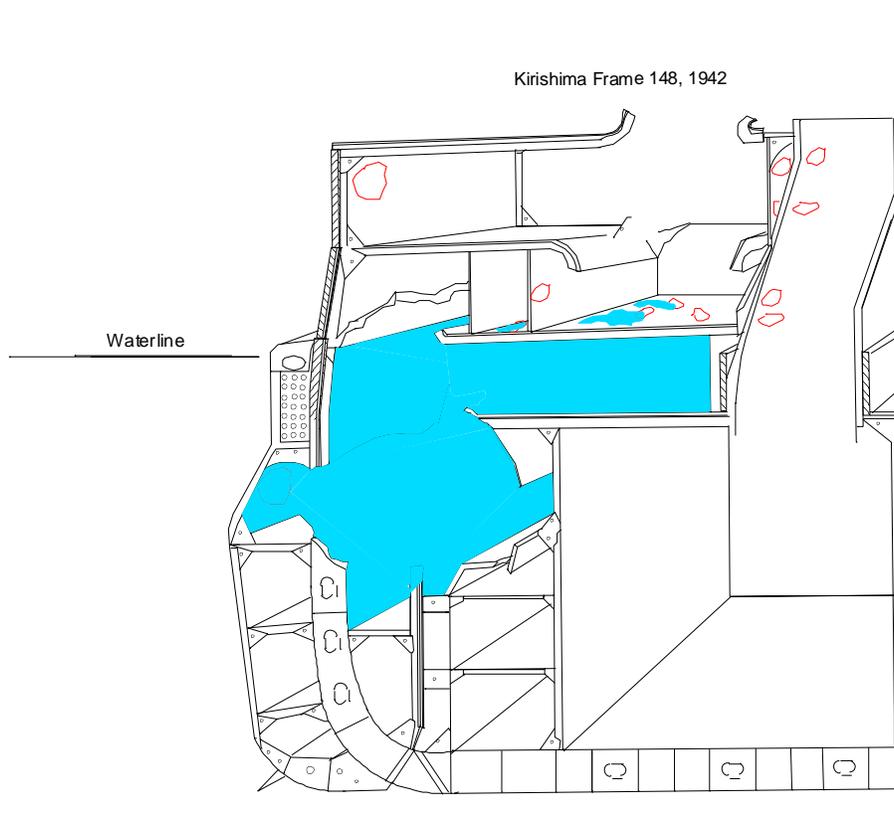
When the XO Commander Koro One ordered port voids flooded to correct the starboard list it only settled the ship lower in the water bringing her entire middle deck below the waterline and allowed the beginning of progressive flooding of the middle deck. When more progressive flooding occurred she will flip over to a port list and the XO ordered more starboard voids flooded which again simply settles the ship lower and allows more water onto her upper decks and she flops back to starboard. Eventually, flooding the port voids will not correct the starboard list but only increase the rate of flooding from starboard and the starboard list steadily grew.

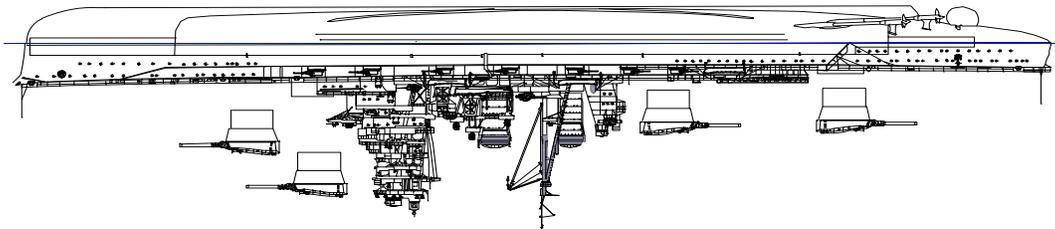
1. *Kirishima* capsizes and her four main battery turrets fall out.

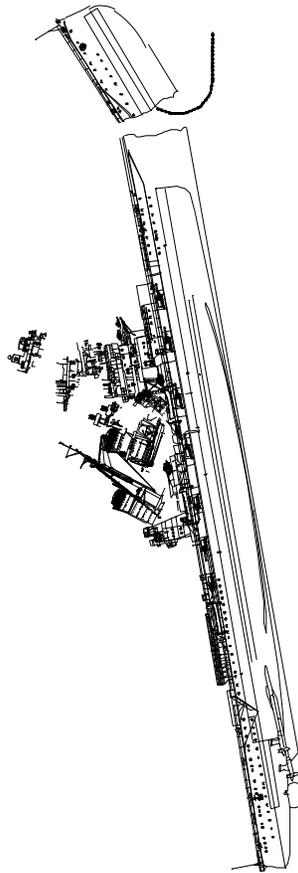
2. *Kirishima* plunges by the stern and sinks in a nearly vertical position. Her bow remains largely air filled forward and wants to remain at the surface but her hull fails where she took a direct hit at the forward chain locker and begins to spill out this chain. Her stacks and superstructure begin to fall away as she plunges and it is unknown what condition her Pagoda superstructure would remain in as she sank but it too may have taken significant damage and broken up on the decent due to other parts of her superstructure slamming into it, any destruction of the tripod supports could seriously break up the rather simple platform decks the Pagoda is built up on. In the case of USS *Northampton* her tripod mast actually imploded but the debris field is filled with so many small pieces of junk that what remains of *Kirishima*'s superstructure could not be identified.

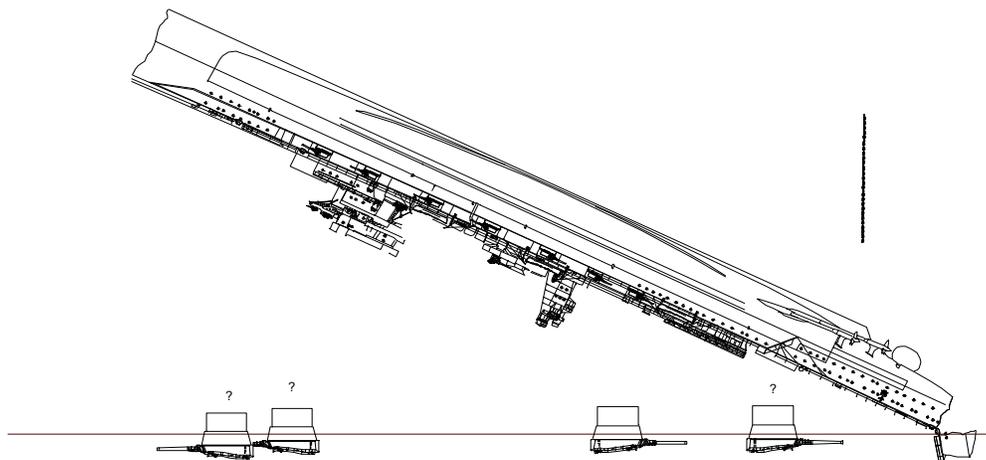
3. *Kirishima* lands on her stern, burying the tip into the mud which then breaks off. Turret three lands in the mud and the other turrets may have also landed in the approximate positions they used to be in and the hull simply lands on top of them and when it does pushes them deeper into the mud because of the weight of her hull. The chain falls down towards the stern.

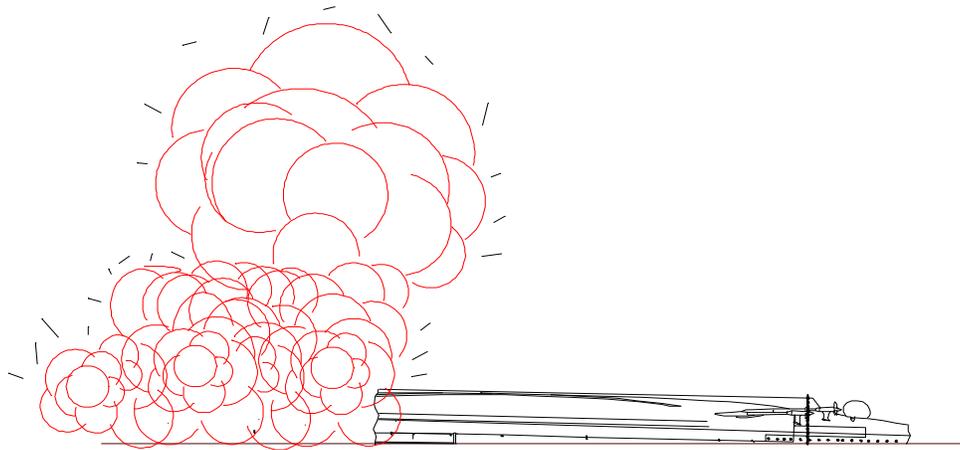
5. Now resting on the bottom, the pressure within the hull on any air filled compartment is roughly 1,633 psi. If these compartments flood in a progressive manner the air will be forced out slowly and the pressure on the compartment will equalize as it floods. However if a compartment suffers a sudden and complete decompression caused by bulkheads collapsing, then the shock will be tremendous as all that pressure is released at once. Within her secondary shell magazine are literally thousands of 6-inch and 5-inch common projectiles filled with an explosive filler *Shimose* or picric acid. This explosive filler is very sensitive to shock and if this compartment suffered a sudden decompression it would only take one shell to start the chain reaction among thousands. I

suspect roughly 40 minutes after she sank one of her secondary shell magazines explodes due to a sudden decompression of the compartment.
