Hit 3 – Starboard side of Turret I

Hit 4 – Frames 46 and 47

Hit 5 – Flag Bridge Level

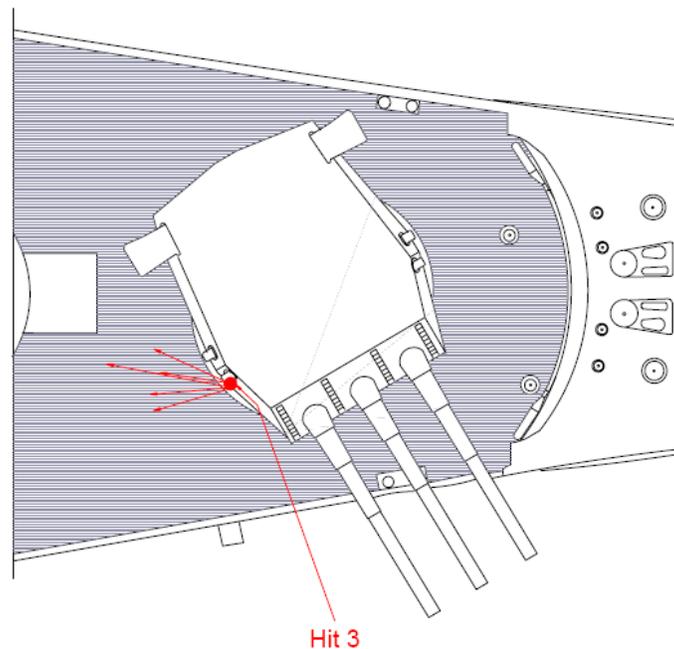
Figure 10 – Hit 3 – Impact Point on Turret I

16. The starboard side of Turret I was struck a glancing blow by a projectile, probably 6-inch, which exploded on the starboard sight port. The hinge on the sight port was bent and the closing device on the port was rendered inoperative. Seven strakes of wood deck planking between frames 44 and 48 were badly splintered by fragments.²⁶

A shell struck starboard side plate #1 turret approximately parallel passed through the 25 man life raft* and exploded on the starboard sight port. Hinge on sight port bent and distorted. Closing device on port inoperative.

7 strakes on wood deck planking splintered and gouged by shrapnel between frames 44 and 48, main deck 4' to 6' inboard of shell plate.

There are no inconsistencies between the reports for this hit and it probably was a 6-inch shell from Kirishima. Another possibility is a 5.5-inch shell fired by one of the light cruisers during the time between 0048 and 0054. The specific time of this hit is unknown and the exact bearing of Turret I at the time of the hit is also unknown, but it was certainly trained to starboard in the direction of the Japanese ships as shown above in Figure 10.

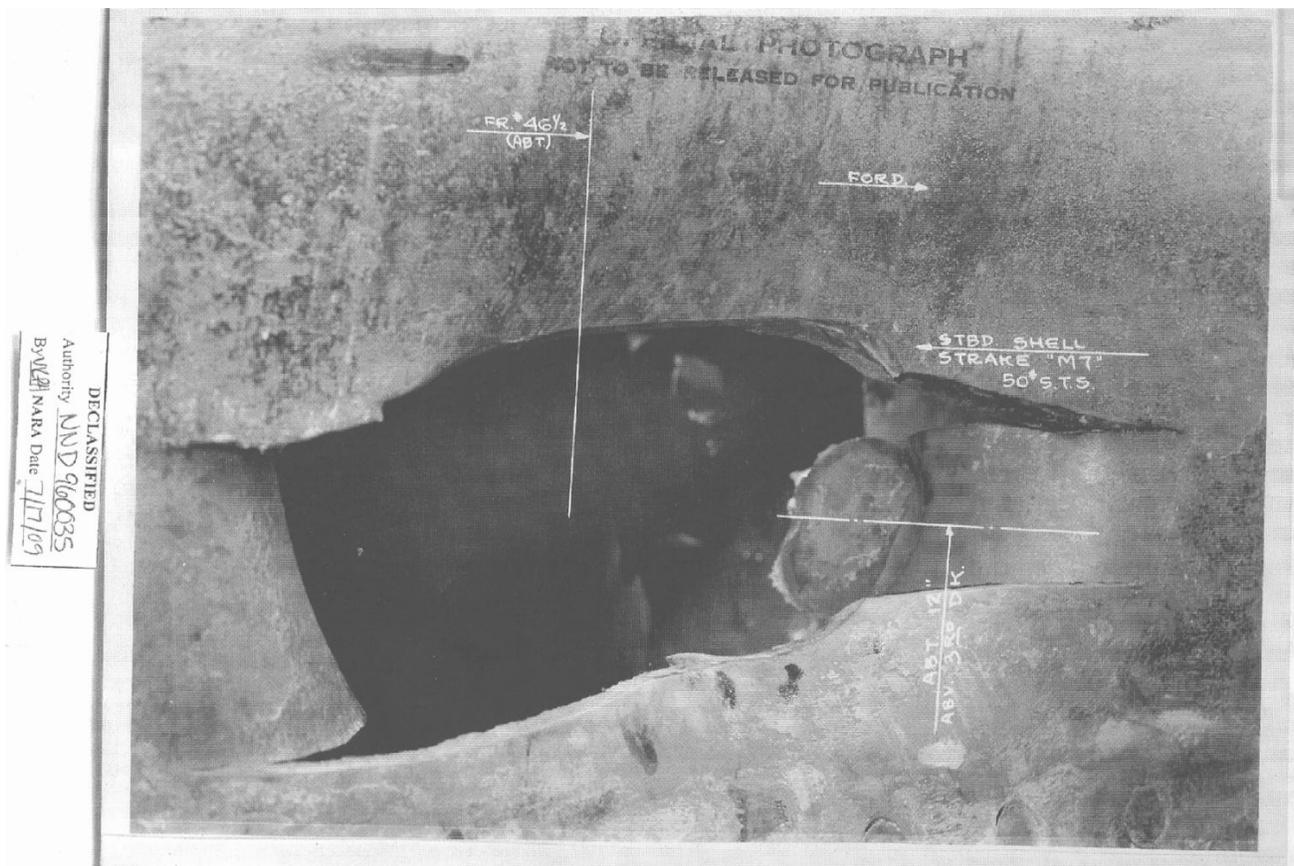
Figure 11 – Hit 4 – Entry Hole

17. This hit struck between frames 46 and 47 about one foot above the third deck. It penetrated longitudinal torpedo bulkhead No. 2 and detonated on the 12.2-inch longitudinal armor bulkhead about 2 feet 2 inches above the third deck. The armor was not indented, but the projectile left a black circle about 6 inches in diameter within a partial black ring about 8 inches in diameter on the face of the armor. The force of the explosion blew the third deck down 3-1/2 inches over a 15 by 30 inch area and fragments penetrated the third deck between bulkheads No. 2 and the longitudinal armor bulkhead in two places. Torpedo bulkhead No. 2 above the third deck was blown outboard between frames 46 and 47 by the force of the explosion. The following tanks were reported flooded as a result of the hit; A-11-F, A-21-F, A-23-F, A-33-F and A-39-F. Although it was not mentioned in the report, A-27-V probably flooded also.

18. This projectile most likely landed short of *South Dakota* and was about to ricochet as the hit was below the waterline and the projectile was rising. From the black circles which the projectile left on the armor, it is estimated that this was an 8-inch AP projectile.²⁸

South Dakota's action report simply lists this damage as a 12-inch hole located 2.5 inches below the waterline at Frame 46.²⁹

The flat face of the shell body also left a mark on the outer shell as seen to the right side of the exterior hole in Figure 11. This flat face is unique to AP shells and the 12-inch hole plus the circular scar on the main belt as seen in Figure 11 really helps with the identification of this shell type.

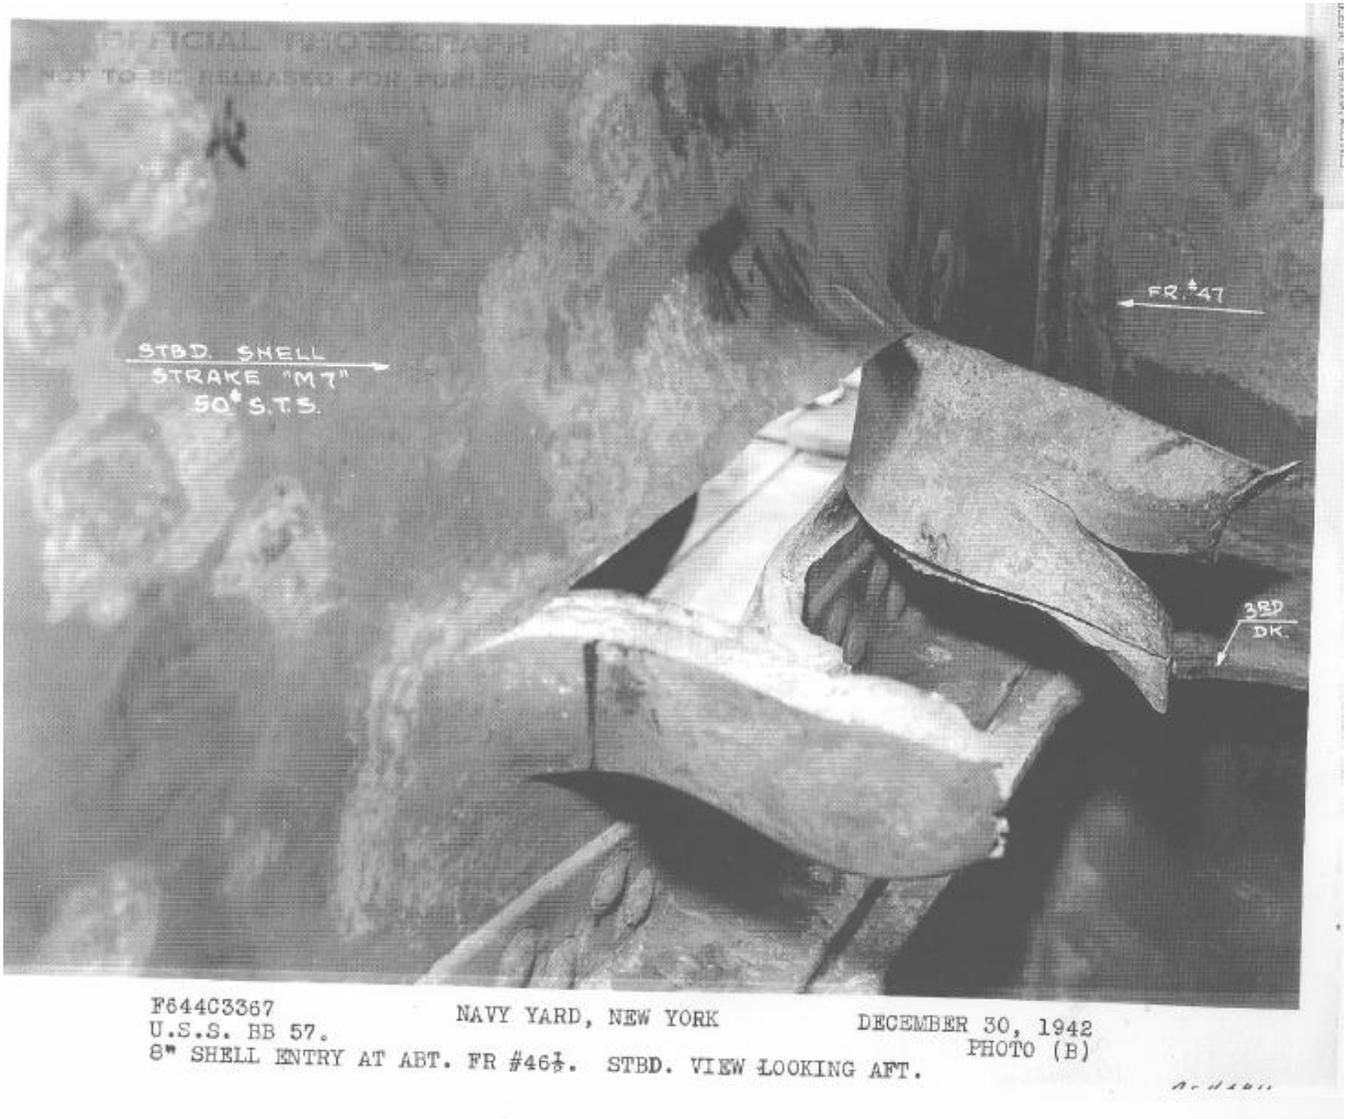
Figure 12 – Hit 4 – Inside view of Entry Hole

Figure 12 also shows a circular scar on the end of the extrusion closest to the camera which was caused by the flat head of the AP projectile.

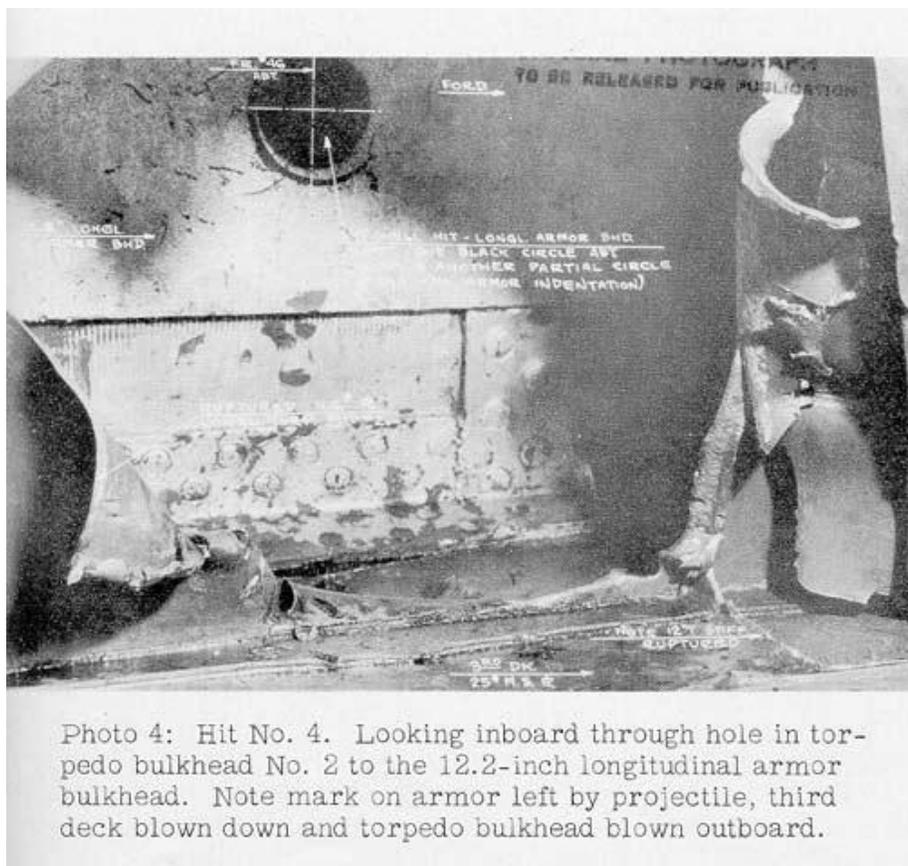
Figure 13 – Hit 4 – Main Belt Strike

Photo 4: Hit No. 4. Looking inboard through hole in torpedo bulkhead No. 2 to the 12.2-inch longitudinal armor bulkhead. Note mark on armor left by projectile, third deck blown down and torpedo bulkhead blown outboard.

Note that Figure 13 and Figure 14 also show that the main belt was not dented in any way; there is mainly just a “scuff” mark on the armor plate.

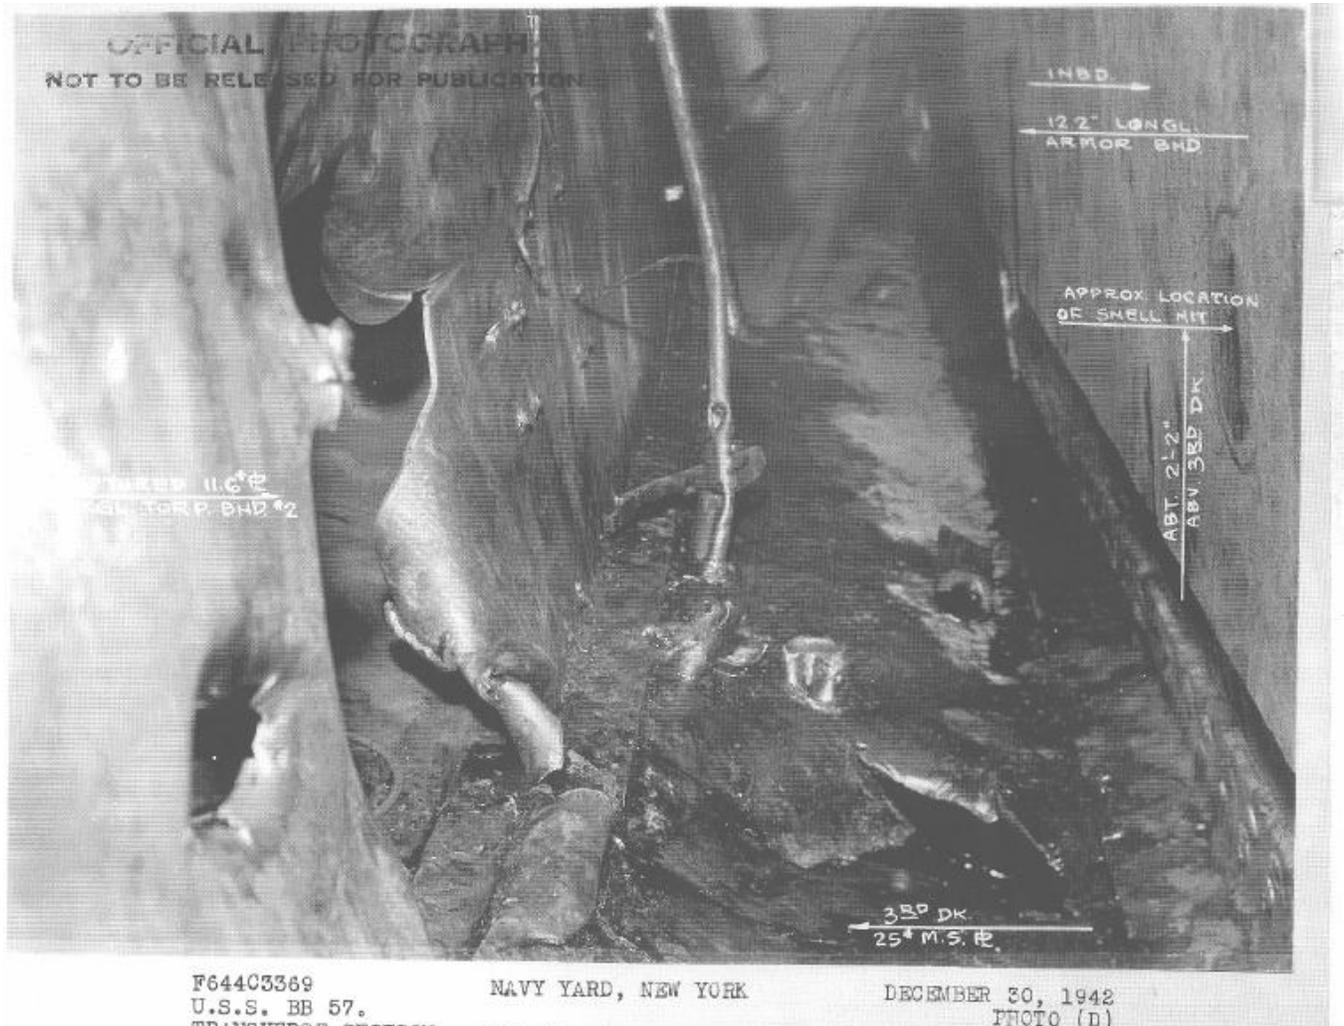
Figure 14 – Hit 4 – Torpedo Bulkhead and Main Belt

Figure 14 shows how this projectile came in from the left through the Second Torpedo Bulkhead and then struck the Main Belt on the right.

There are no inconsistencies with this damage or with BuShips’ estimate of an 8-inch AP projectile.³⁰ Although this shell was slowed down by its underwater trajectory, it still had enough velocity remaining to penetrate the torpedo defenses and reach the main belt but not enough to significantly damage the plate.

The 8-inch AP projectile punched a rectangular hole out of the 1.25-inch STS outer hull which implies that it must have hit at a significant horizontal obliquity, but with minimal angle of fall. The windscreen was smashed flat and broken up by the impact with the outer shell, but the cap head remained on the projectile nose until it went completely through and even then did not have time to move much before the projectile eventually terminated its flight up against the belt armor. The projectile with the cap head still “riding” on its nose then punched through the HTS upward extension of the first internal anti-torpedo bulkhead and then it hit the main belt, where it destroyed itself, leaving only a 5-inch wide black circular disk on the face of the belt plate with an 8-inch wide narrow black ring surrounding it. What made the black color is unknown, but it might have been due to the impact shock of the 5-inch diameter flat nose under the crushed cap head and/or transmitted blast shock of the shell detonation removing paint and a very thin surface layer of the cemented part of the plate face, exposing the dark carburized layer that makes up about 1 inch of the plate thickness. The 8-inch ring might be due to the thick 8-inch diameter base hitting the armor after the projectile body in front of it had been destroyed. Other than this, the belt plate had no damage whatsoever.

Note that the hole in the upward extension of the anti-torpedo bulkhead is about 35 to 40 inches wide and was almost exactly in the center between two of the ship’s vertical ribs, so nothing was there to modify the size of the hole in the horizontal direction. This portion, which is above the main 0.75-inch HTS anti-torpedo bulkhead, is thinner at 0.625 inches thick HTS. This plate was possibly still wrapped around the base of the projectile when the nose hit the belt armor and the shell detonated by impact shock. The internal cushion would not prevent such a detonation when the front of the shell shattered and the damage cut into the explosive cavity and the shell seems to have fully detonated high order, though this is not absolutely assured.

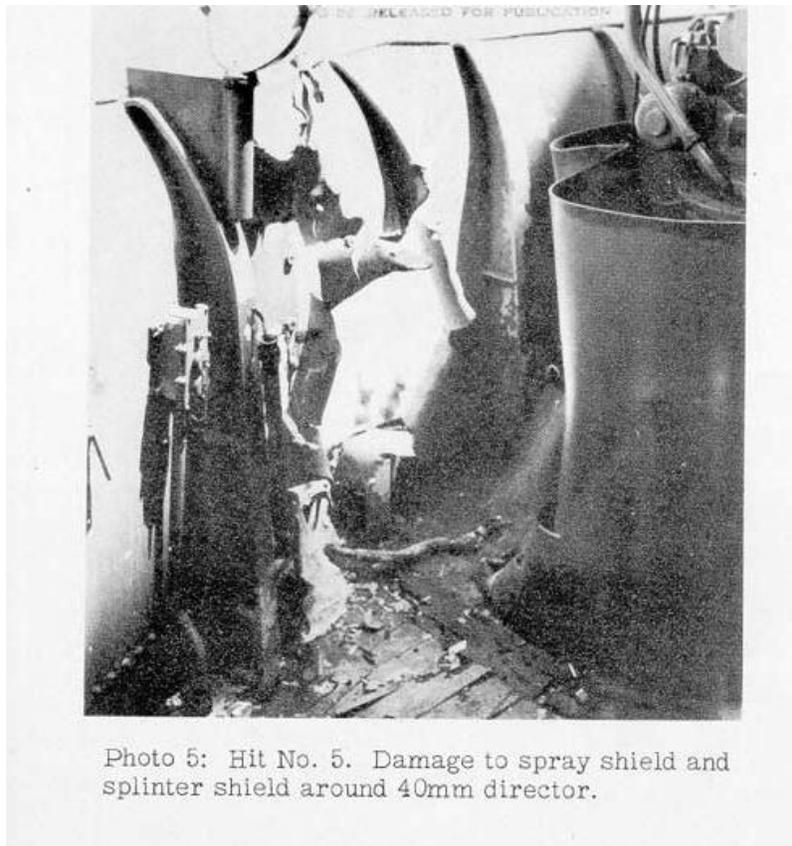
Figure 15 – Hit 5 – 40 mm Director

19. The wind and spray shield at Frame 74 starboard on the flag bridge level was hit by an estimated 8-inch projectile that detonated on contact. The 10-pound STS splinter shield around the starboard 40 mm director was badly buckled and holed and the 40 mm director was extensively damaged. Fragments from this projectile penetrated the deck of the flag bridge in the vicinity of Frame 74 and the watertight door between the signal bridge and signal shelter. One fragment gouged a hole 3 inches in diameter to a depth of 3/4 inch in the 1-1/2 inch STS bulkhead of the signal shelter. Other fragments blew downward and sprayed the first super structural deck between frames 66 and 72 starboard and penetrated hatch 01-07-1 in eleven places. On the navigation bridge fragments from this projectile penetrated the spray shield and the starboard longitudinal structural bulkhead in two places and the deck in three places near Frame 75. Extensive blast damage was sustained by metal joiners, ventilation ducts, aluminum bulkheads, and metal furniture in the vicinity of the hit. Three glass panels on the flag bridge were broken by blast or fragments and the operating mechanisms rendered unserviceable.³¹

The information on this hit covers multiple pages within *South Dakota's* action report. Damage extended from the 1st superstructure deck level to the Navigation deck level. The only photograph in BuShips' report (shown above as Figure 15) is of fragment damage to the 40 mm director, but does not show the point of impact. However, a search of the archives did turn up a photograph of the entry hole as seen below in Figure 16.

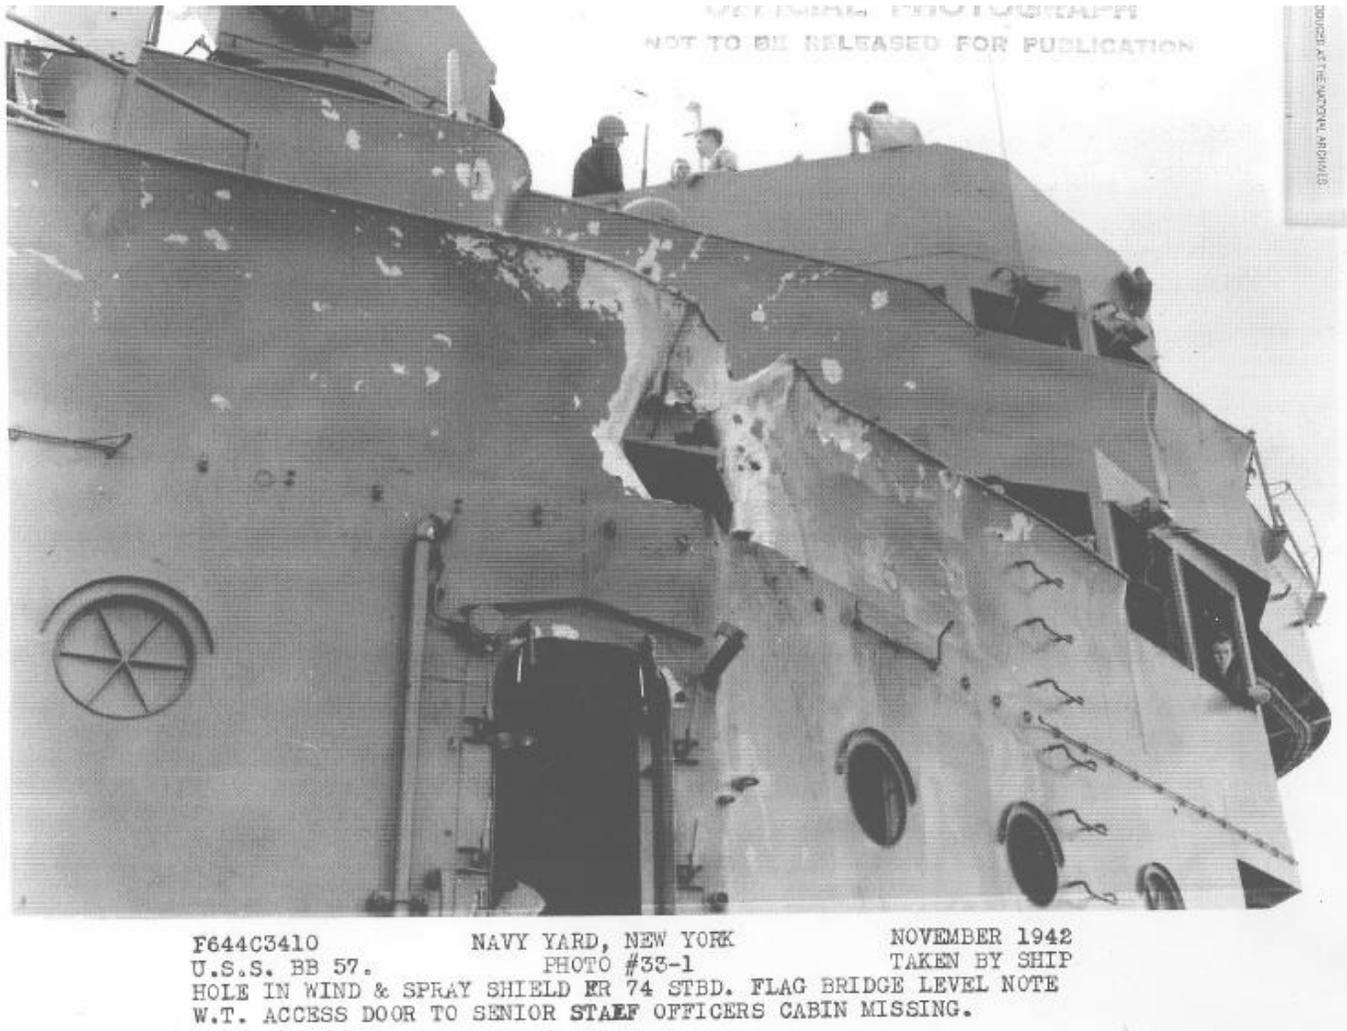
Figure 16 – Hit 5 – Entry Hole

8" shell struck the upper edge of bulkhead plating of spray shield and Flag Bridge, Frame 72 1/2 starboard, resulting in the following damage:

This shell is certainly a nose-fuzed projectile. The original crew estimated it to be an 8-inch projectile and this appears to indeed be the case. Despite the level of description in *South Dakota's* Action Report about this hit, there was not a good sense of the hole it produced in the exterior bulkhead of the Flag Bridge until I found the photograph in Figure 16 which shows about a six foot hole in the Flag Bridge windscreen. The thickness of the exterior bulkhead on the Flag Bridge windscreen is 0.25 inches of STS steel. This projectile appears to have detonated on impact and blasted inboard into the Senior Staff Officer's stateroom and Admiral's cabin. The door to the Senior Staff Officers cabin was blown off due to blast overpressure from Turrets I and II, and the fact that it is missing is not associated with the 8-inch HE projectile hit above.

This calculated hole diameter is about 6.7 feet, which is close to the 6-foot hole size documented in the report.

Even taking into account the smaller explosive filler of the 14-inch Type 0 HE projectile; $254.24 \times 0.864 = 219.66$ inches or 18.3 feet, this size projectile would have resulted in the bulkhead completely disappearing! Clearly, this hole was not made by a 14-inch projectile and the best estimate is an 8-inch Type 0 HE projectile.

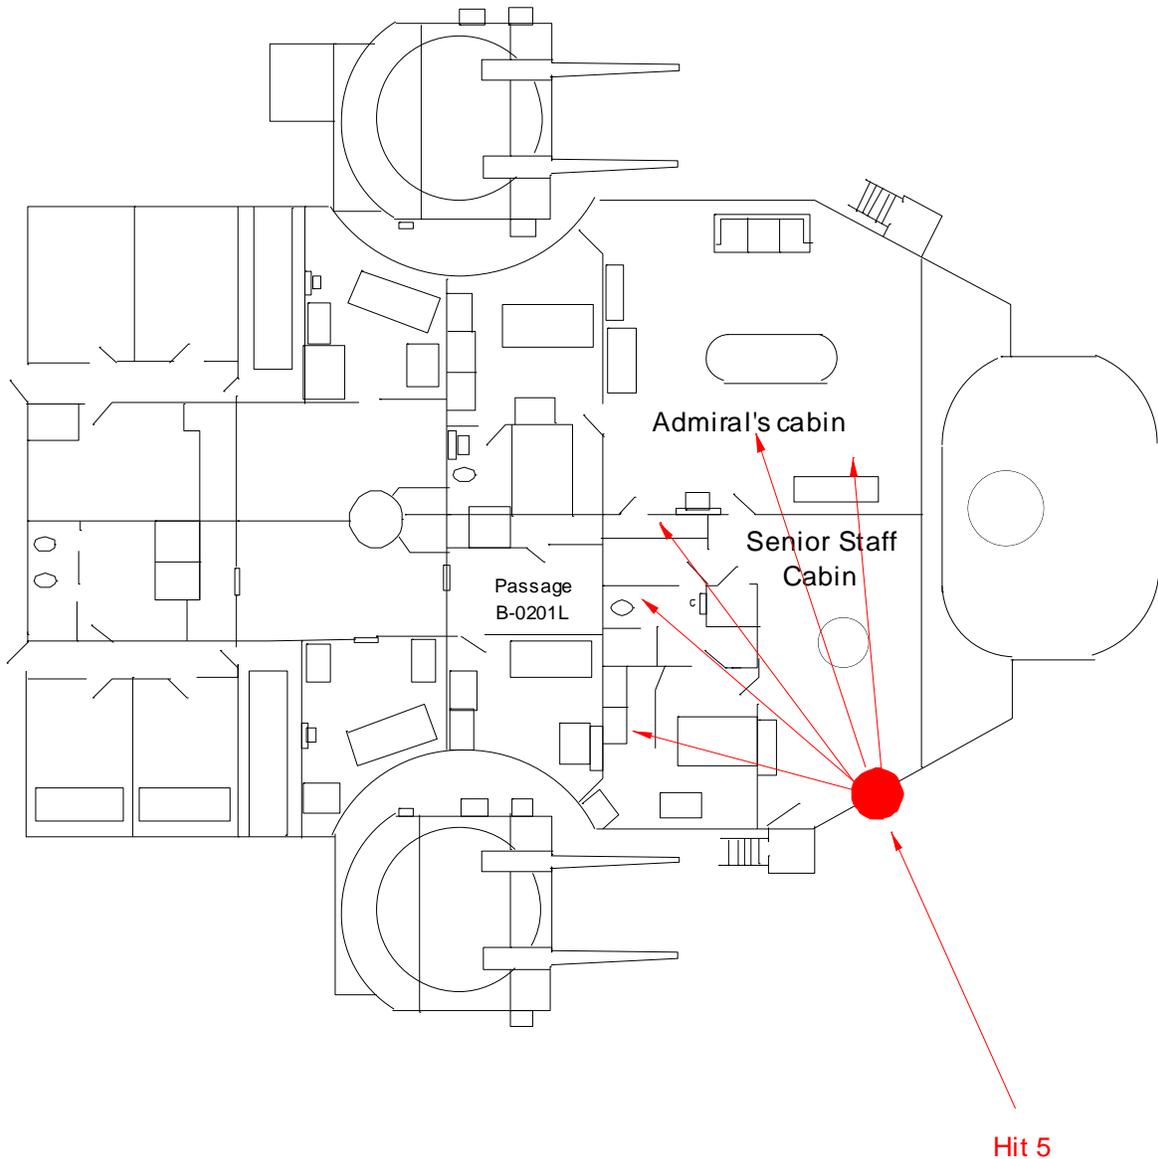
Figure 17 – Hit 5 – Path of Shell and Splinters

- (a) Shrapnel blew downward penetrating wood and steel deck on first superstructure deck starboard between frame 66 and 72, approximately 45 holes ranging in size from 1/2" to 5".

Watertight access door 03-79, to B-0305E is badly distorted.
6' section of exhaust vent duct, compartment B-0305E, completely blown out.
1 section vent duct leading to pre-heater supply system 03-79-1 blown out.
Sides, drawers, and fastenings to signal bridge desk torn and distorted beyond repair.
Hole, 12" x 36" in outboard corner of starboard flag bag.
3" fragment hole 3' above bottom starboard end.
Light metal tissue blown out.
5' section of 4" drain line severed at frame 83, starboard.
2" drain line pierced and severed by shrapnel, frames 72 and 73 starboard.
1 1/2" voice tube, starboard alidade to conn, severed at frame 73.
6' square of wind and spray shield and stiffeners at frame 73 starboard demolished by salvo.
1/4" STS splinter shield around the starboard 40 mm director at frame 74 demolished
40 mm director demolished.
5 square feet areas of wood deck planking and margin steakes [sic] splintered and broken. Steel deck plating beneath wood deck in this area penetrated by several pieces of shrapnel.

Wet and dry bulb thermometer casing demolished, frame 77 stbd.
4" hole in wind and spray shield 3' above deck level at frame 75, starboard.
1 6" hole, 1 3" hole and 1 4" hole in deck from shrapnel at frame 75 starboard.
1 3" and 1 2" shrapnel hole located in longitudinal structural bulkhead 1' above deck level at frame 75, starboard.
4" hole in spray shield 3' above deck at frame 75, starboard. [Ed's note: This may be a duplicate of above entry.]
1 3" and 1 2" shrapnel hole in longitudinal structural bulkhead 1' above deck level at frame 75, starboard.
1 6" shrapnel hole in circular base of starboard alidade.
1 section 3' by 5' in spray shield between frames 70 and 71 starboard blown inboard and distorted.
Swivel base scat (mess stool) on spray shield at frame 72, starboard demolished.
Watertight door access from pilot house to catwalk bent and distorted at frame 71, starboard.
Pipe rail and fittings supporting canvas windbreaker around catwalk port and starboard broken and unserviceable. Canvas windbreaker blown out.

The large number of shell fragments of relatively small size for this hit is typical of a HE shell due to the large cavity and thinner sides of that kind of projectile. The only heavy cruiser to fire Type 0 HE projectiles was *Atago* as *Takao* fired only AP ammunition during this battle. *Atago* was the last heavy cruiser to open fire at 0103 and there is only a brief period of time during which she is ahead of *South Dakota*, as she was in the lead of the Japanese formation. Since *Atago* was part of the bombardment group, she may very well have been loaded with Type 0 HE shells for her first salvo. Her ammunition report says that she fired a total of six HE shells during the battle.³⁶
