***Lessons Not Learned: Cruise
Missile Attacks on USS STARK
(FFG-31) and
INS HANIT (FFL-503)***

Robert H. Stoner, GMCM (SW) (Ret)

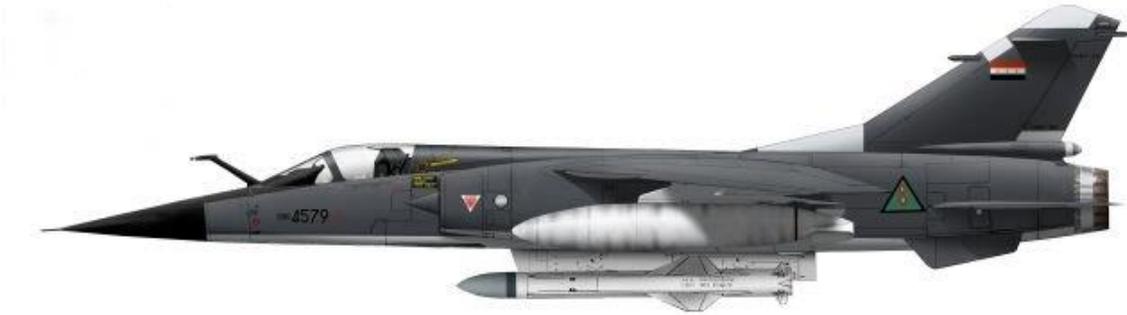
Above: An Iraqi Dassault F.1EQ-6 configured for maritime strike with the MBDA AM39 Exocet air-launched anti-ship missile. (Art: ACIG.com)

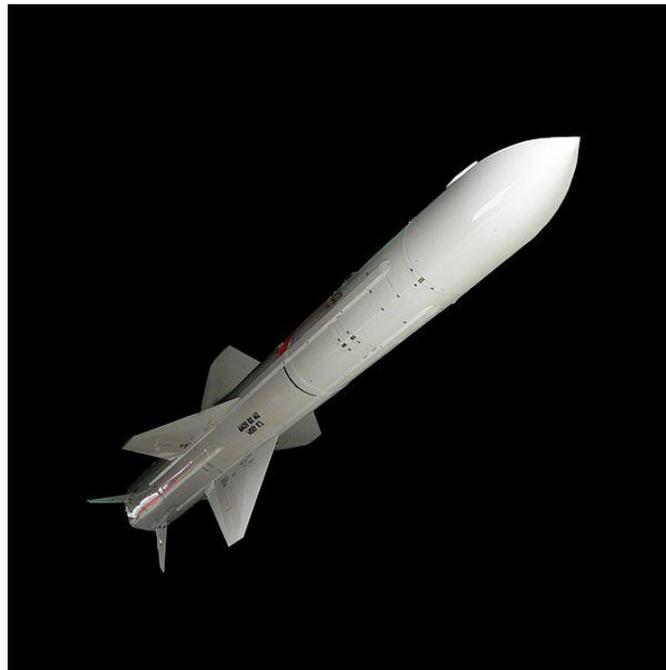
Below: The MBDA AM39 Exocet missile in close-up. (Photo: David Monniaux)

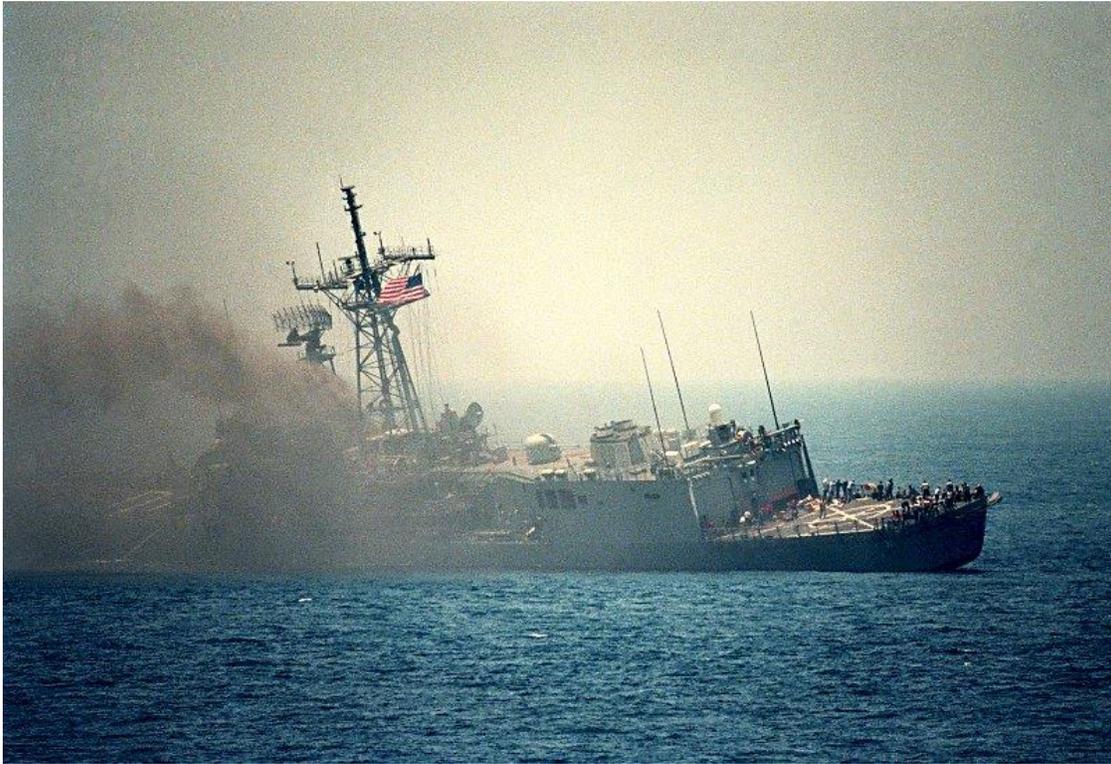
Above: USS STARK on the morning of 18 May 1987 shortly before the fires were contained and put out. Note the heavy list to port and the dense smoke from the fires. The ship's fire parties fought the fires all night long. (Photo: Navsource.org)

Fires raged aboard STARK. Captain Brindel ordered the starboard side compartments flooded to keep the gaping hole on the portside above the waterline. Throughout the night the fate of the stricken frigate was in doubt. By the next day, STARK's fires were under control, and the frigate limped back to port in Bahrain for emergency repairs by the tender USS ARCADIA (AD-42). After repairs, STARK sailed back to her homeport of Mayport, FL. Repairs at Pascagoula, MS eventually cost \$142 million.

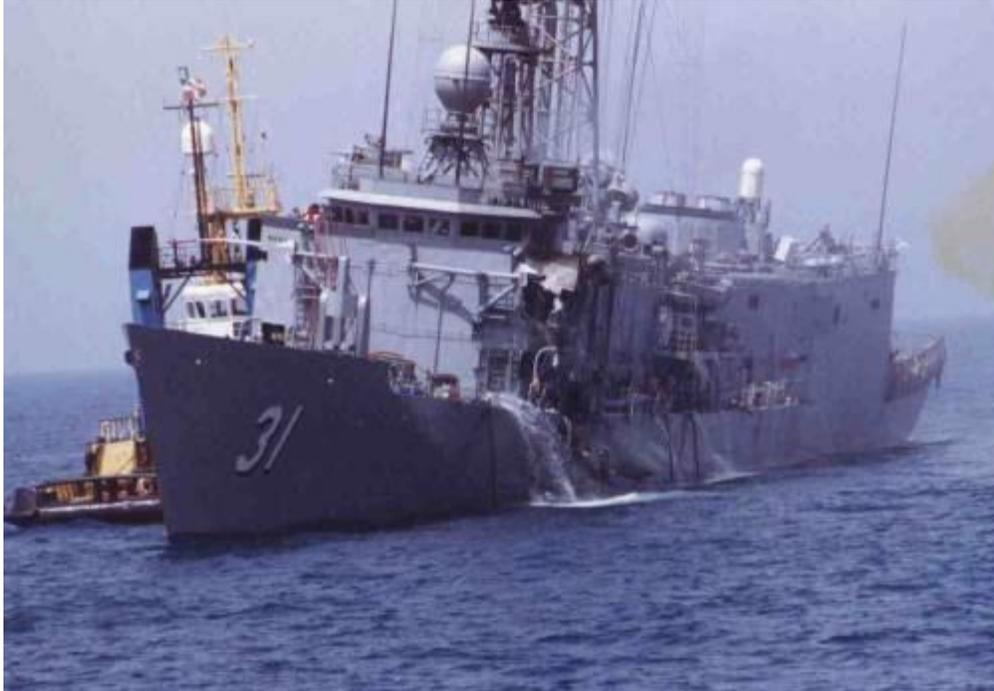
Above: STARK, with an ocean-going tug alongside for assistance. The fires just about extinguished and dewatering of flooded spaces is underway. (Photo: Navysite.de)

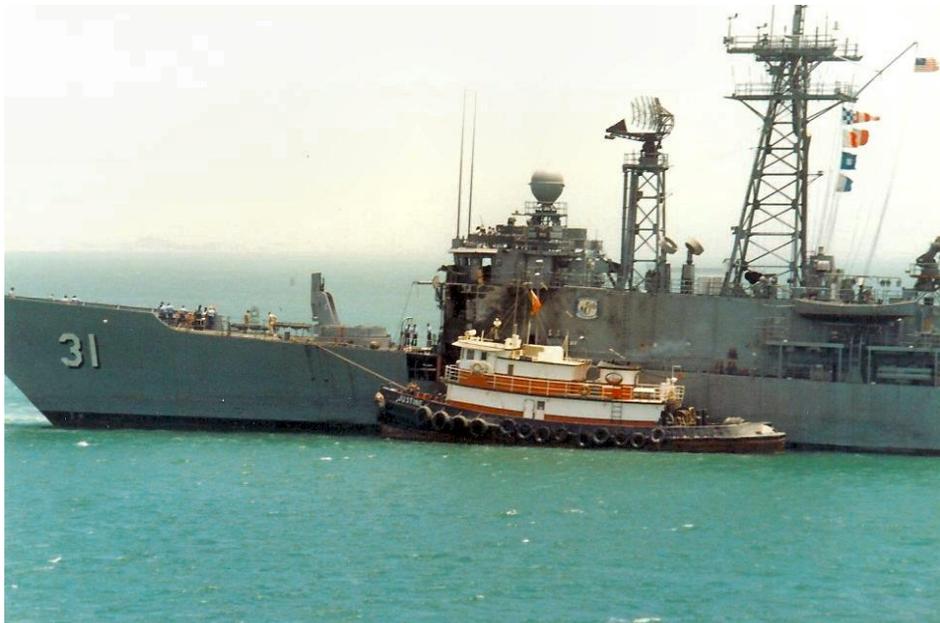
Below:, A tug provides assistance to STARK at Bahrain. This photo was taken from the USS COONTZ (DDG-40). (Photo: Edward Cleary via Navsorce.org)

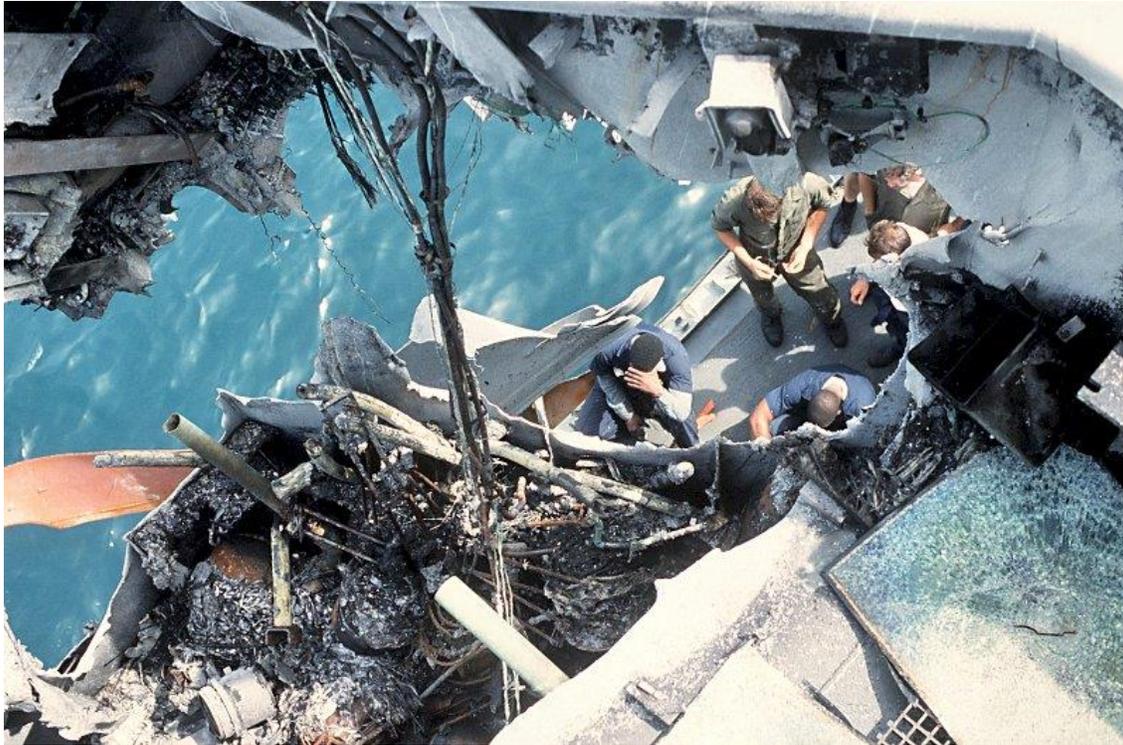
Above: Looking down to the main deck from the port bridge wing (01 level). Note that the explosion has completely blown the steel deck away. (Photo: Navsource.org)

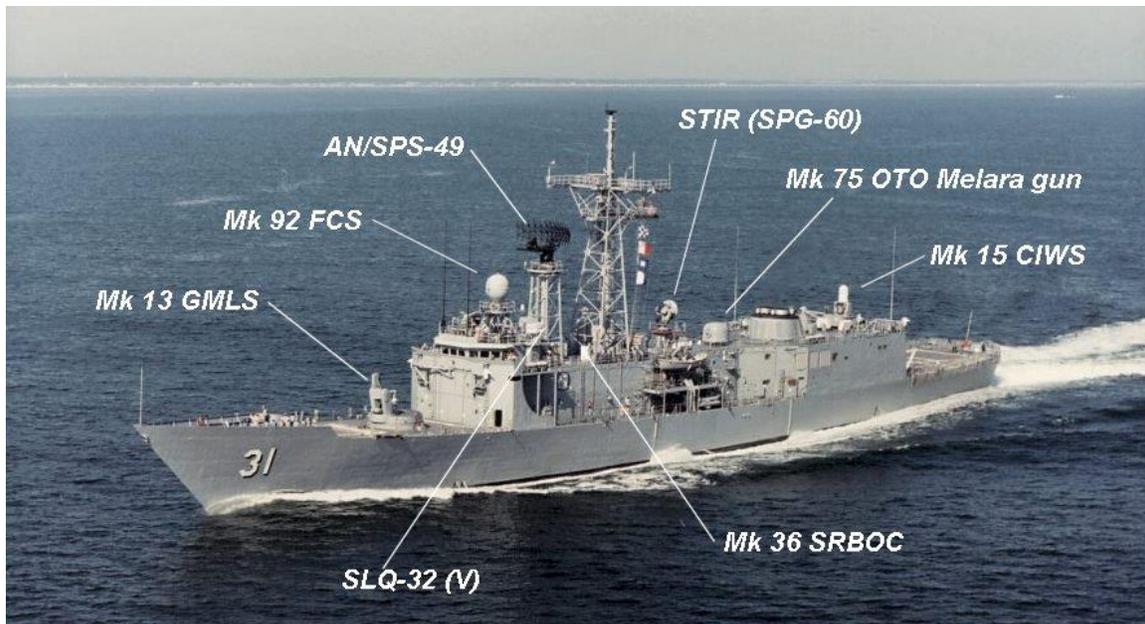
Above: USS STARK (FFG-31) with the various anti-ship missile defense systems identified. (Photo: U.S. Navy, notations Bob Stoner)

- The Mk 13 Mod 4 Guided Missile Launching System (GMLS) with a magazine of 40 Standard SM-1 missiles.
- The Phalanx Mk 15 Mod 0 Close-In Weapons System (CIWS).
- The Mk 75 Mod 0 OTO Melara rapid-fire 76mm dual-purpose (anti-air and anti-surface) gun.
- The Mk 36 SRBOC decoy system.
- The SLQ-32 (V) 2 electronic warfare.
- The AN/SPS-49 (V) 4 air search radar.
- The Mk 92 Mod 2 Fire Control System, STIR (SPG-60) gun, missile fire control radar.

Fact: No weapons were fired to protect the ship at the time of the attack. The Phalanx CIWS remained in STANDBY mode (effectively out-of-action). The Mk 36 SRBOC decoys were not armed and ready for use. The attacking Iraqi Mirage F.1 and its Exocet missiles were in blind spots for both CIWS and STIR that prevented use of the ship's SM-1 missile system. No evasive maneuvers were performed before first missile impact.

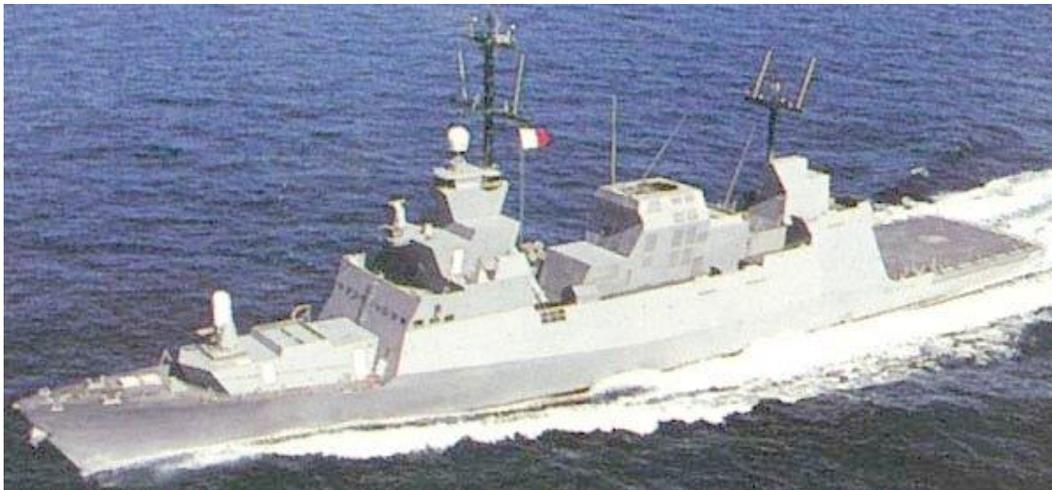
Below: The Sa'ar V is an indigenous Israeli design considered to be on the cutting edge by naval architects. During the early 1990s, Israel took delivery of three Sa'ar V corvettes: INS EILAT (FFL-501), INS LAHAV (FFL-502), and INS HANIT (FFL-503). Of these, HANIT was the last delivered in August of 1995. Litton-Ingalls Shipbuilding (now Northrop-Grumman Ship Systems) built all three corvettes for Israel in Pascagoula, Mississippi. The cost was \$260 million for each one. (Art: Northrop-Grumman Ship Systems)

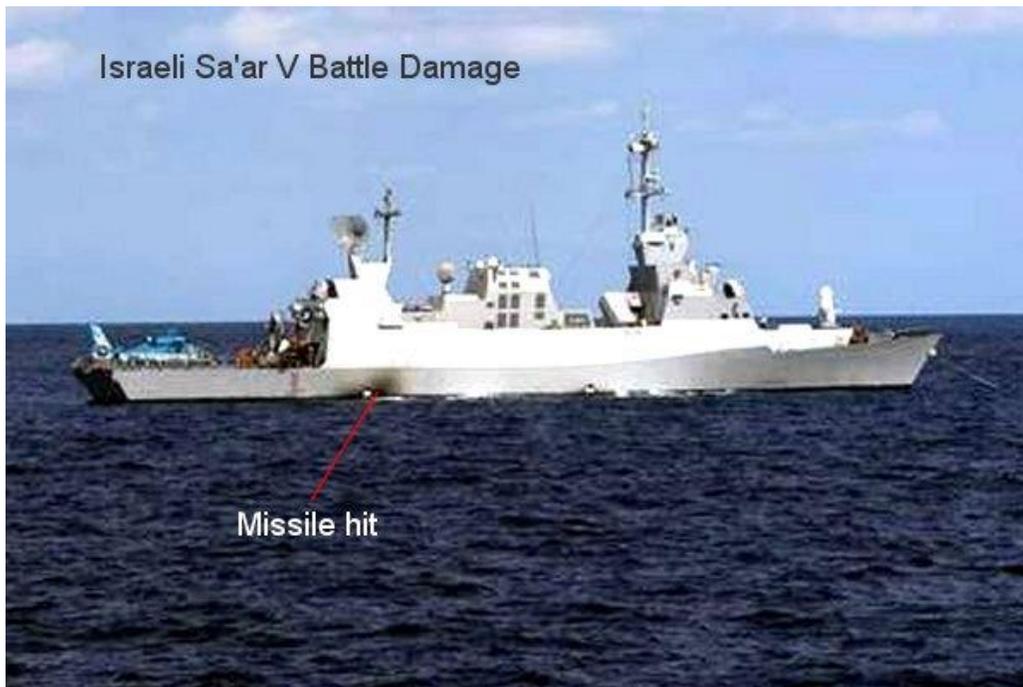
Above and below: Photo of INS HANIT at anchor after the attack and before return to Ashdod for repairs. These photos were published on the Internet within several days of the attack. Over three years later, very few photos of the battle damage are

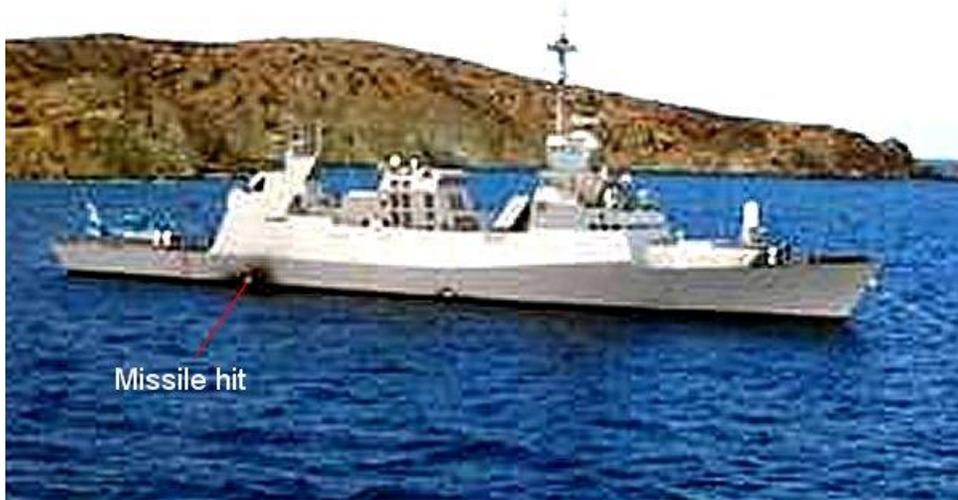
Above: HANIT alongside the pier at the Israeli Ashdod Naval Base. Fire and blast damage is apparent to the helicopter hangar and starboard side hatch. (Photo: Israeli Navy)

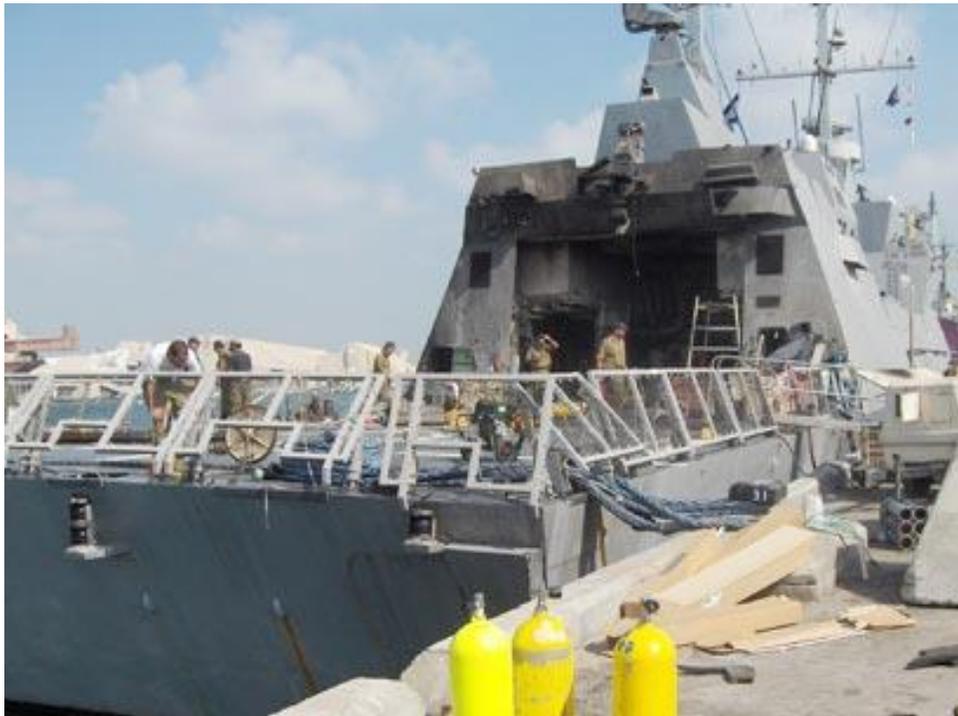
Below: The after helo deck damage. From the pictures, it appears the missile hit the starboard side on an angle and parts of the airframe exited the top of the helo deck to port. The fact that the HANIT did not sink and only took 10 days to repair gives credence to a hit by the smaller C-701 missile and not the larger C-802 missile. (Photo: Israeli Navy).

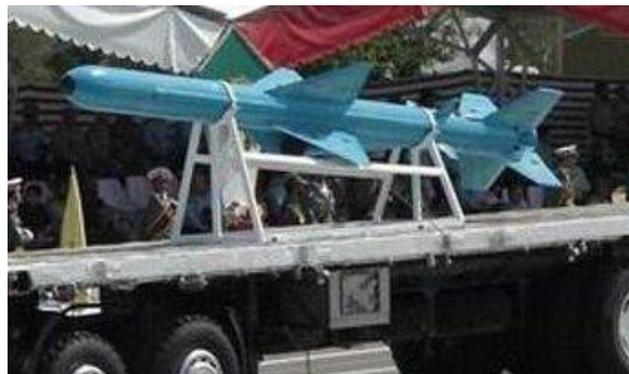
Above: The Iranian-built version of the Chinese C-802 anti-ship missile is called the “Noor”, shown here on a trailer for a military parade. (Photo: ACIG via IRIB)

The Chinese C-802, called “Saccade” by NATO and “Noor” by Iran, uses a rocket booster for launch, and a turbojet cruise engine, giving it a range of up to 70 nm. The warhead uses about 396 pounds of shaped charge explosives. This heavy warhead makes it a capable threat to major warships including U.S. aircraft carriers.

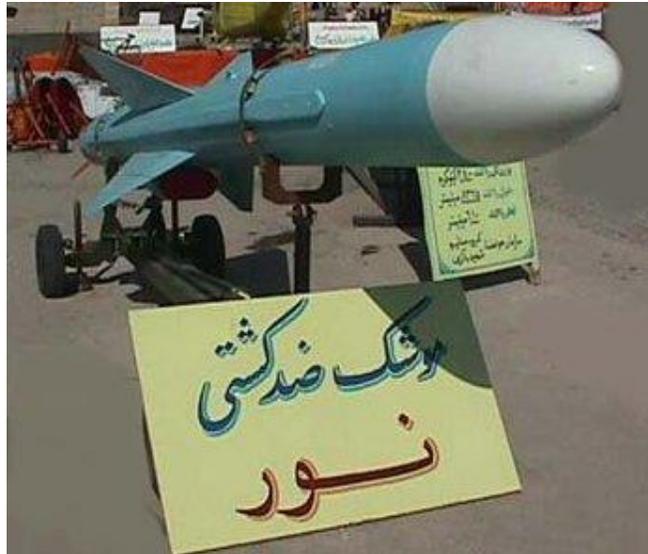
Below: The Iranian-built version of the Chinese C-701 anti-ship missile is called the “Kosar” or “Kowsor”, shown here at a weapons display. (Photo: AboveTopSecret.com)

The C-701, (known as “Kosar” or “Kowsor” by Iran) is as a truck mounted coastal defense missile. It is much smaller than the C-802. The C-701 weighs about 220 pounds, has a range of 9-10 nm, and a 63-pound high explosive warhead with a delayed-action fuze to maximize internal damage after hull penetration. The C-701 uses an Infrared/TV seeker or an active millimeter radar seeker.

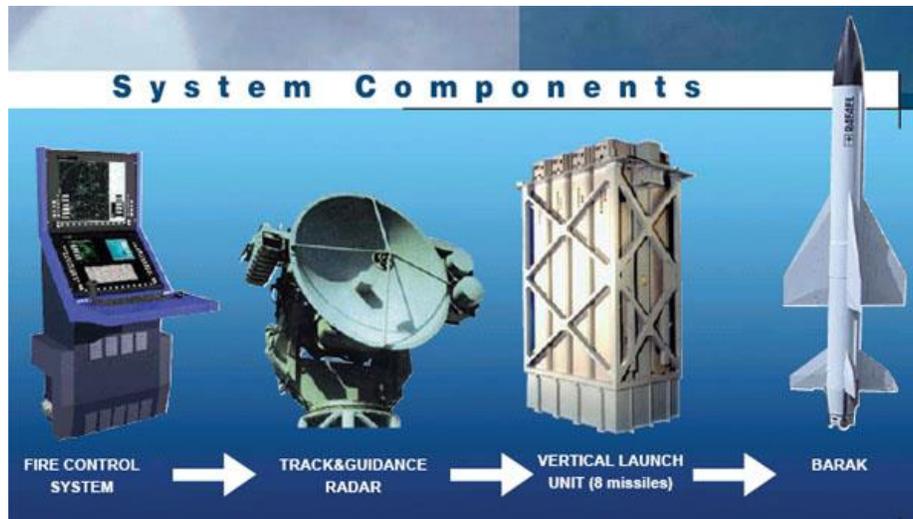
Below: The Barak vertical launch SAM system is a joint project of Israeli Aerospace Industries and RAFAEL Advanced Defense Systems. The total system is summarized in the following artwork. (Art: IAI/RAFAEL)

Fact: The Israeli-made Barak ship defense system was in optimum condition to track, identify and intercept the Chinese-origin or Iranian-copy missiles, *had it not been deactivated prior to the attack.*
