Kirishima Damage Analysis

By Robert Lundgren
Edited by Tony DiGiulian

1. Introduction

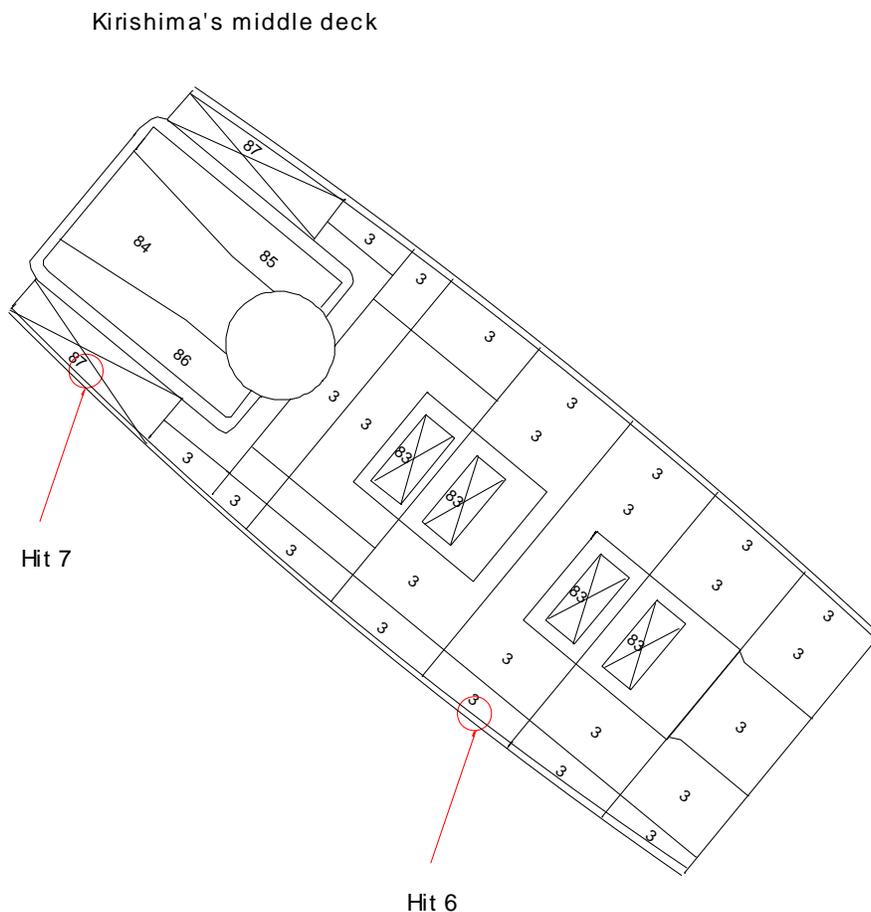
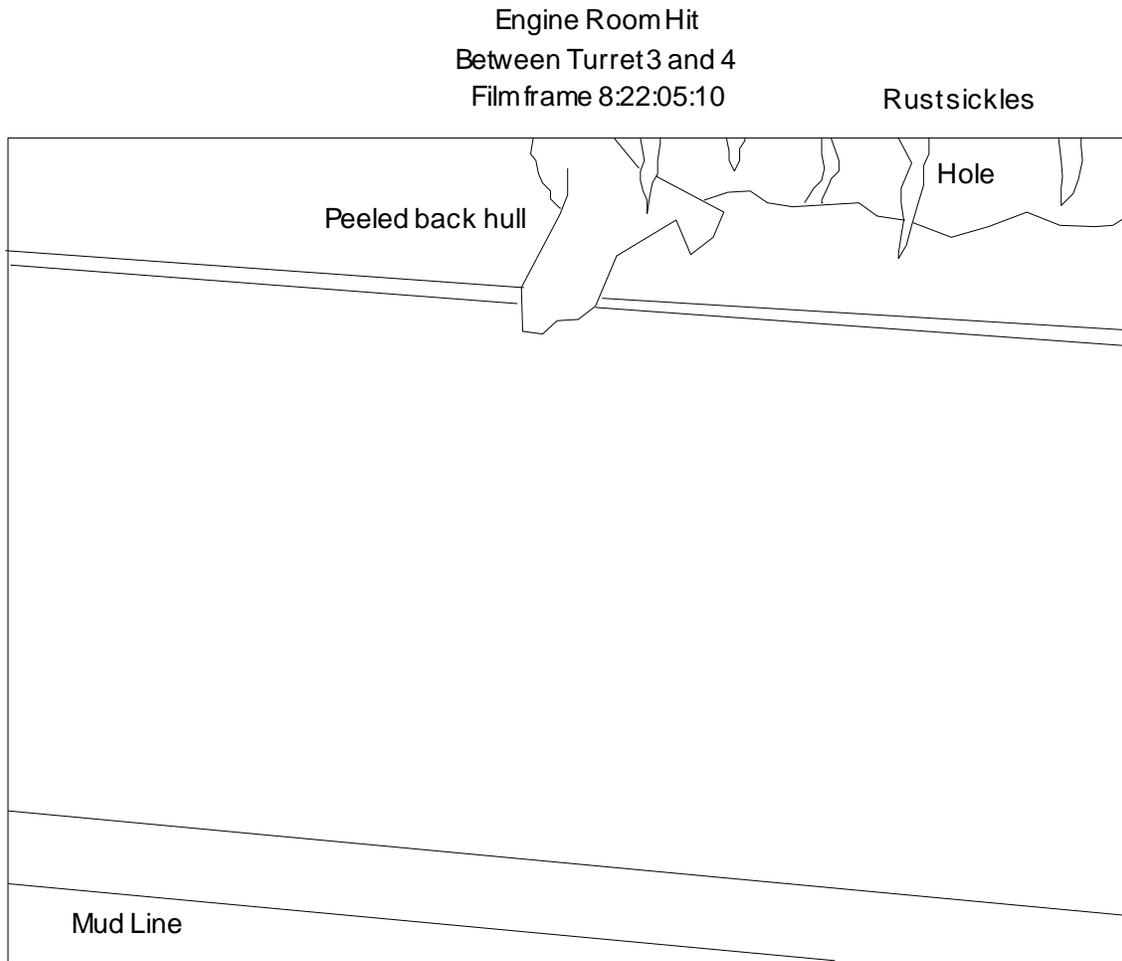
Hit 1 – This large caliber hit is the only hit clearly in the pagoda superstructure and is in the location of the compass bridge and the forward telegraph room. This was the first hit observed by Hank Seely on *Washington*'s second salvo and what Ikeda described on the third bridge level a scene of total destruction. This hit is also documented in her brief action report. This was the only hit observed for the second salvo.

Hits 2, 3, 4, 5, 6, and 7 – play the most important role in why *Kirishima* was lost. Ikeda observed two ten meter wide holes in the deck right above his secondary guns as he moved aft in all likelihood these were hits 2 and 3. Holes thirty feet in diameter hint on how violent these explosions were and both strike very close to casemate mount 9. Hit 3 struck close to casemate mount 5. Hit 4 would have struck at the base of the pagoda superstructure in the approximate position of the forward 5"/40 gun mount. The drawings below are turned to reflect *Kirishima* on a course of 130 degrees and the shell trajectory matches *Washington*'s course, position and firing angle during the first two minutes and 39 seconds. Hank Seely noted that on *Washington*'s third salvo *Kirishima* was hit amidships, causing large, bright explosions.

The damage done by hits 2, 3, and 4 is very significant in that after penetration of the 149 mm casemate armor the shells would detonate very close to her forced draft supply ventilation for her machinery compartments (number 82). In addition, hits 2 and 3 threaten the aft secondary magazines through ammunition scuttles (number 41) on the lower deck and fires can sweep across to the port side as well,

which would detonate the ready service ammunition for the casemate battery. The upper deck would have been set ablaze. Lt.(jg) Michio Kobayashi first heard reports about fire in aft secondary battery casemates. The XO Commander Koro Ono ordered the aft secondary magazines flooded.

Lt.Cdr. Kyûshichi Yoshino first received reports of fired both forward and aft and then progressive flooding in the starboard engine room and this was prior to the emergency order to flood turret one magazine. Hits 6 and 7 both struck below the waterline and would have been observed by *Washington* as misses. There is partial film on the wreck showing hit 7. The expedition did not film the entire starboard side, so hit 6 was not filmed. These two hits would open both the middle and lower decks due to the armored slope. Hit 6 is by far the more damaging hit because it opens the middle deck with its large compartments which would allow flooding across the ship from starboard to port, which is again documented in that the ship kept shifting from starboard to port and then back again. On the lower deck her side protection kept any fragments from entering the boiler rooms. Hit 7 would have struck a large fresh water tank (number 87). The starboard engine room on the lower deck only reported progressive flooding and this water tank may have played a role in stopping fragments and contributing to this flooding. The engine room remained operational until fires being swept down through the ventilation forced it to be abandoned.

By *Washington*'s fourth salvo, the range has dropped to roughly 7,850 yards and the target angle is approximately 5 degrees as the two ships pass each other in opposite directions. Hits 8 and 9 are again very close together and probably struck turret one simultaneously. For that reason, it would have been difficult for the crew to distinguish these as separate hits. Turret one's destruction must have been quite dramatic as it prompted Captain Iwabuchi's emergency order to flood the magazine for this turret. One simple deduction would be that both forward turrets were smashed. Neither of these forward turrets had any upgrade in armor protection, unlike turrets three and four which both received 124 mm VC plating below the forecastle deck in addition to the original 75 mm VC plate.

Based on Hayashi's drawing, hit 8 may have struck the barbette above the forecastle deck or hit the deck first and then struck the barbette on the after section of the barbette. Hit 9 penetrated between the forecastle deck and upper deck and would have passed through the 149 mm VC casemate armor that angles to the center of the barbette and then through a 75 mm VC plate. The armor protection in this area is too thin to stop the projectiles. Hit 10 may also have struck the forecastle deck and then penetrated the 38 mm NS deck plating to enter crew quarters and passage ways.
